# Silver Creek Town Hall Structural Assessment

**Silver Creek Township  
1891 Town Road, Two Harbors, MN 55616**

August 26, 2025  
KOA No. 251139

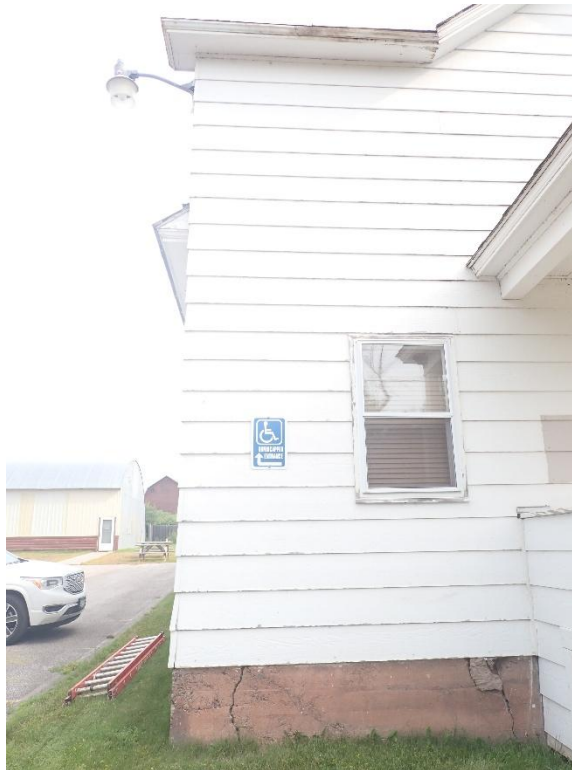
- The original building has a poured concrete foundation. The interior of the foundation walls were not visible due to spray insulation covering the surfaces.
- There were multiple cracks noted at the south foundation wall:
  - A vertical crack was noted about 17-20" from the southeast corner (*Photo 1 & 2*)

**Photo 1: Vertical Cracks at SW Building Foundation**

1. The following foundation conditions are recommended to be addressed by a qualified professional(s):
  - a. The cracking in the original building's concrete walls should be repaired to prevent water infiltration into the systems. Recommendations for what should be used to fill/repair cracks are as follows:

- i. Cracks less than 1/8-inch thick: epoxy crack injection system
    - ii. Cracks larger than 1/8-inch thick: flexible sealant
  - b. The spalls noted at the northeast corner of the concrete foundation walls and at the west rail beam southern bearing should be repaired.

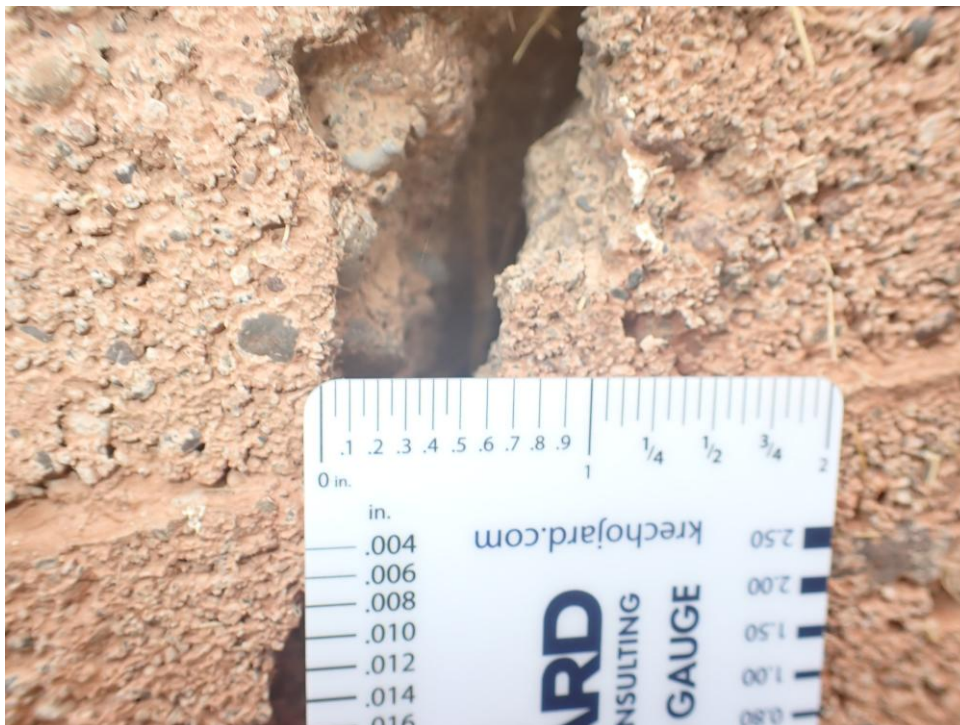
**Photo 2: Crack at SW Building Foundation**

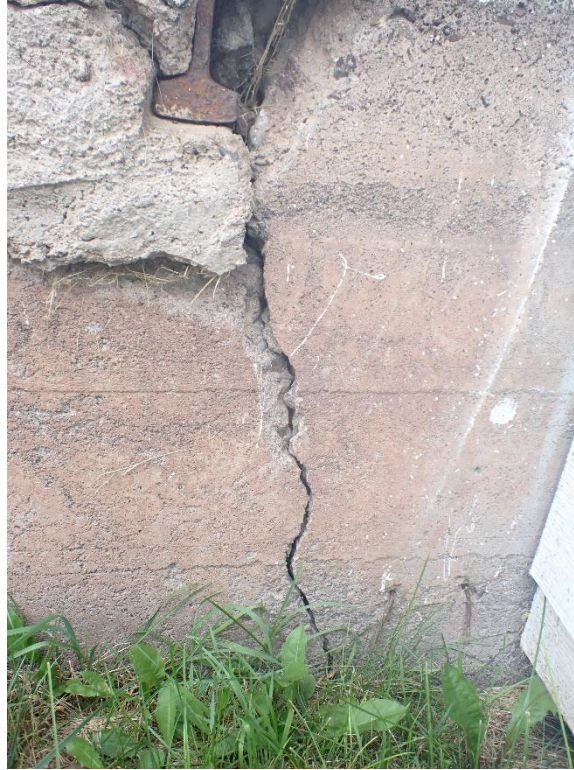
- Vertical crack(s) were noted at the west rail beam bearing, spalling of the concrete/grout infill was also noted (*Photo 3*)
- Minor cracks were noted in the east rail beam bearing in the grout and foundation wall (*Photo 4*)
- Spalling was noted at the northwest corner of the foundation walls. (*Photos 5 & 6*)
- Along the east and west walls, intermittent temperature and shrinkage cracks were observed. (*Photos 7-9*)

**Photo 3: Vertical Cracks at SW Wall & Grout Spalling at Beam Bearing**

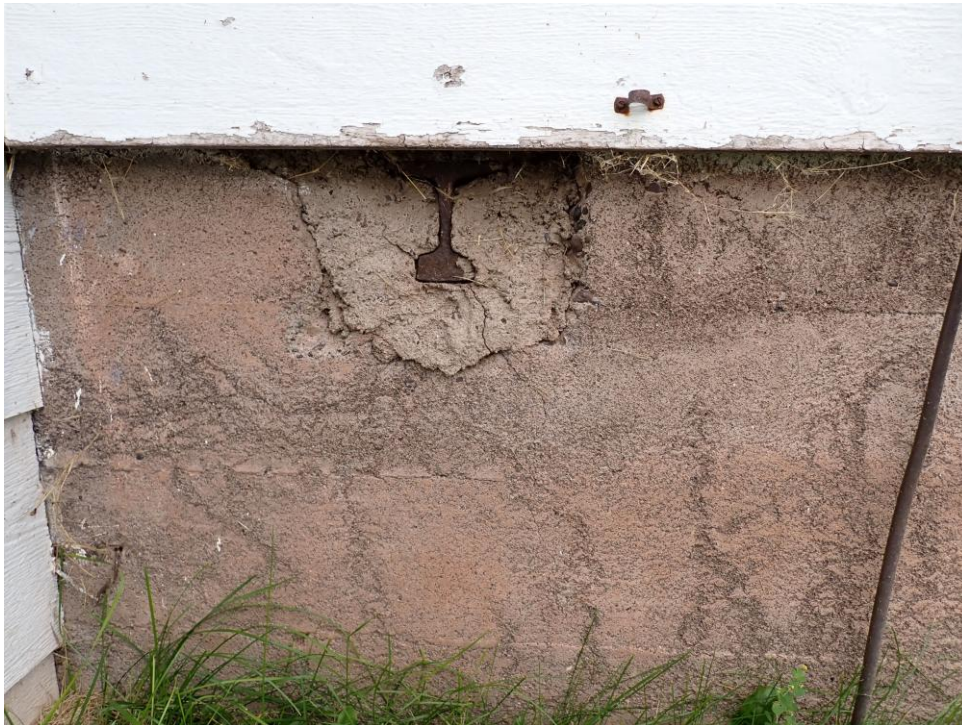
**Photo 4: Crack at SE Building Foundation at Beam Bearing**

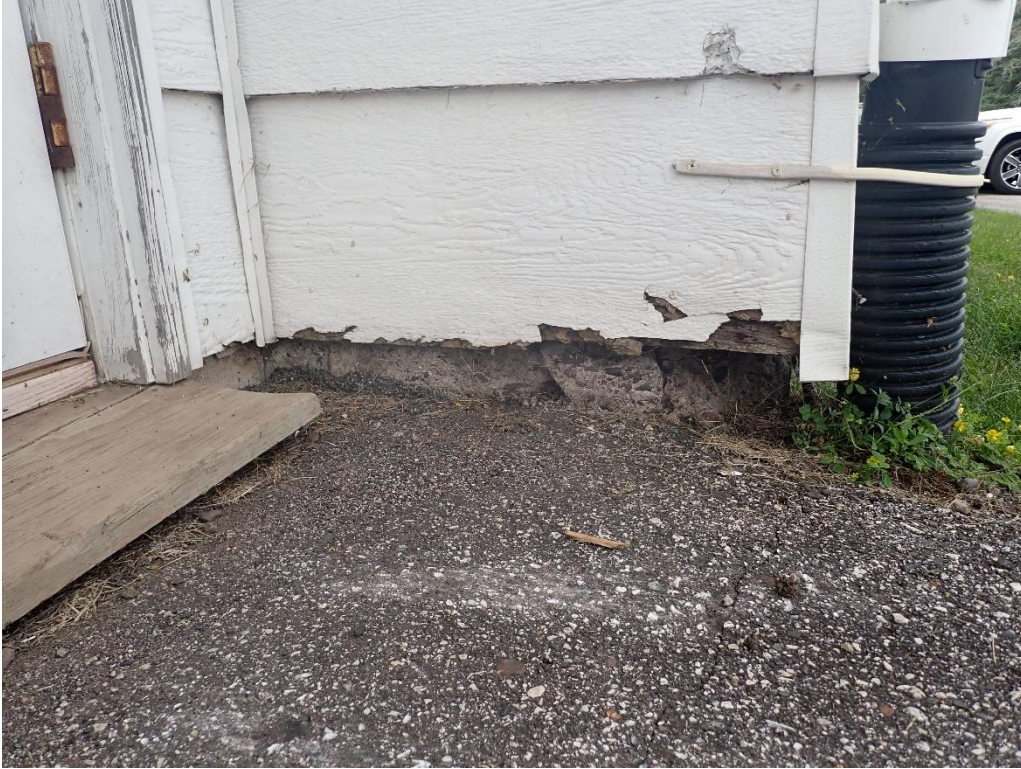
3. The exterior foundation wall of the original building is in generally fair condition. The spalling at the northwest corner of the foundation wall indicates that water seepage may have occurred in this area. A downspout for the gutter system has been installed in this location, and as such, continued water damage at this corner is not anticipated.
4. The exterior foundation wall of the addition is in poor condition and the service life remaining for this system is limited. There are multiple areas with cracking and damaged CMU blocks. The damage seems to indicate that water may have infiltrated the block and that freeze-thaw cycles led to cracking and/or breakage of the CMU.
5. The porch foundation system is in poor condition. There is evidence of frost heaving and movement of the foundations beneath the porch posts.

**Photo 5: Spalling at NE Building Foundation Corner**

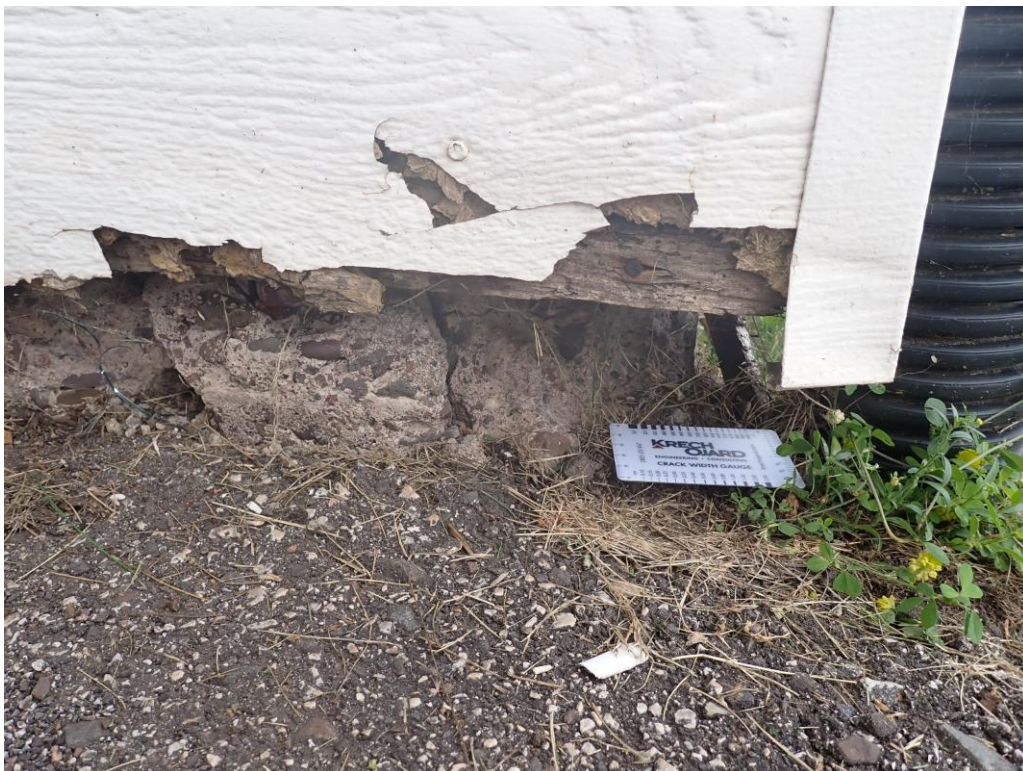
**Photo 6: Spalling at NE Building Foundation Corner**

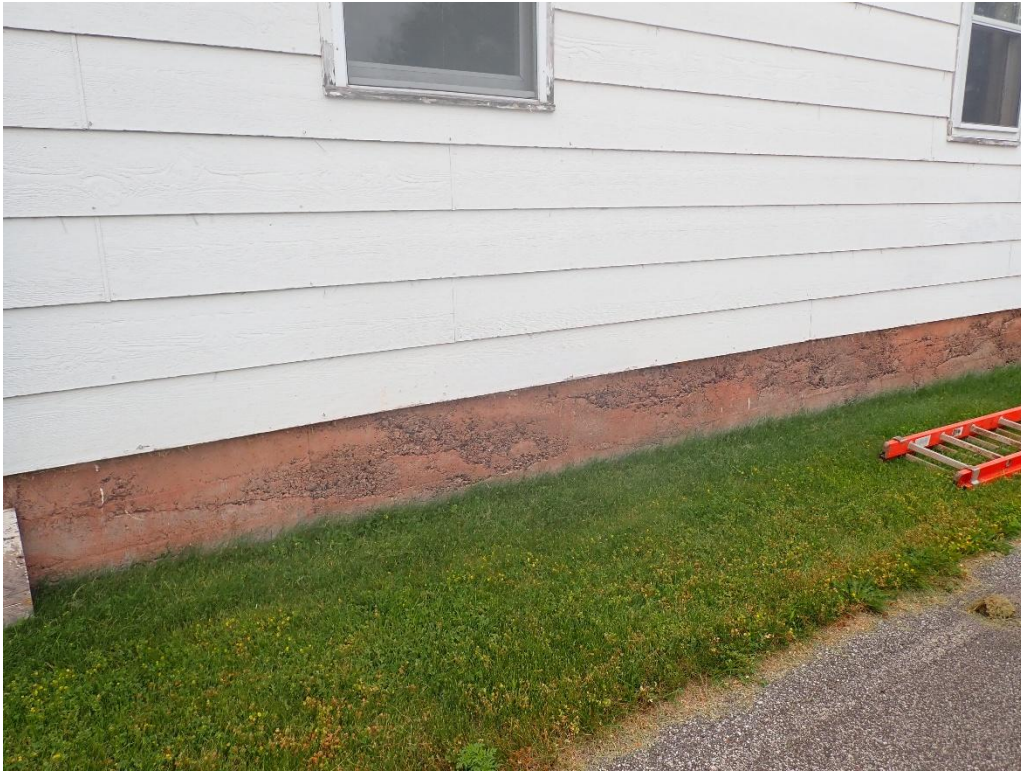
**Photo 7: West Foundation Wall**

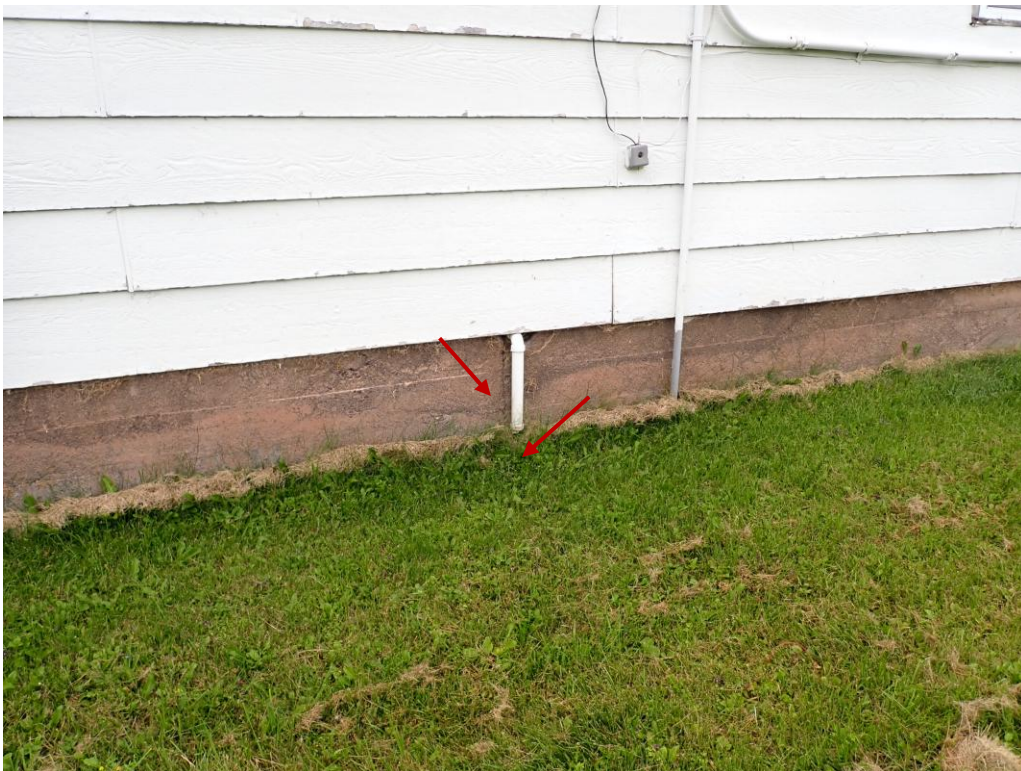
**Photo 8: East Foundation Wall – Crack and Broken Pipe**

- b. Repair the damaged kitchen water drainage pipe at the east wall to prevent water from discharging to grade.
  - c. Repair or replace the chimney extension above the roof to prevent further damage and/or loss of bricks.

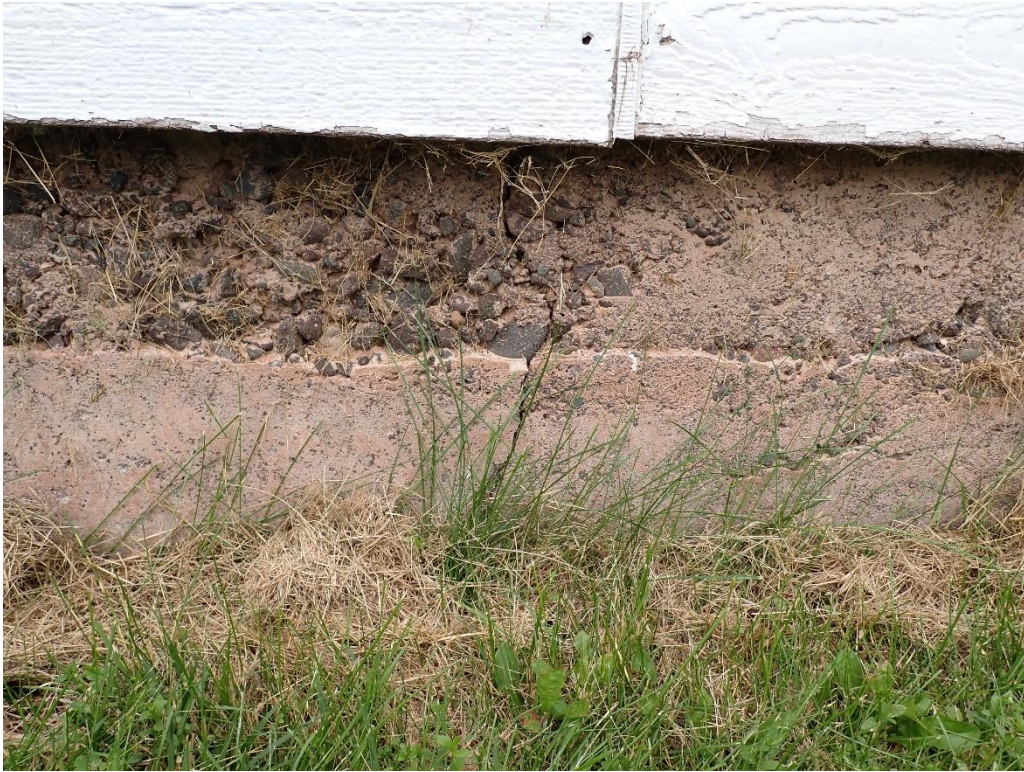
**Photo 9: Crack at East Foundation Wall**

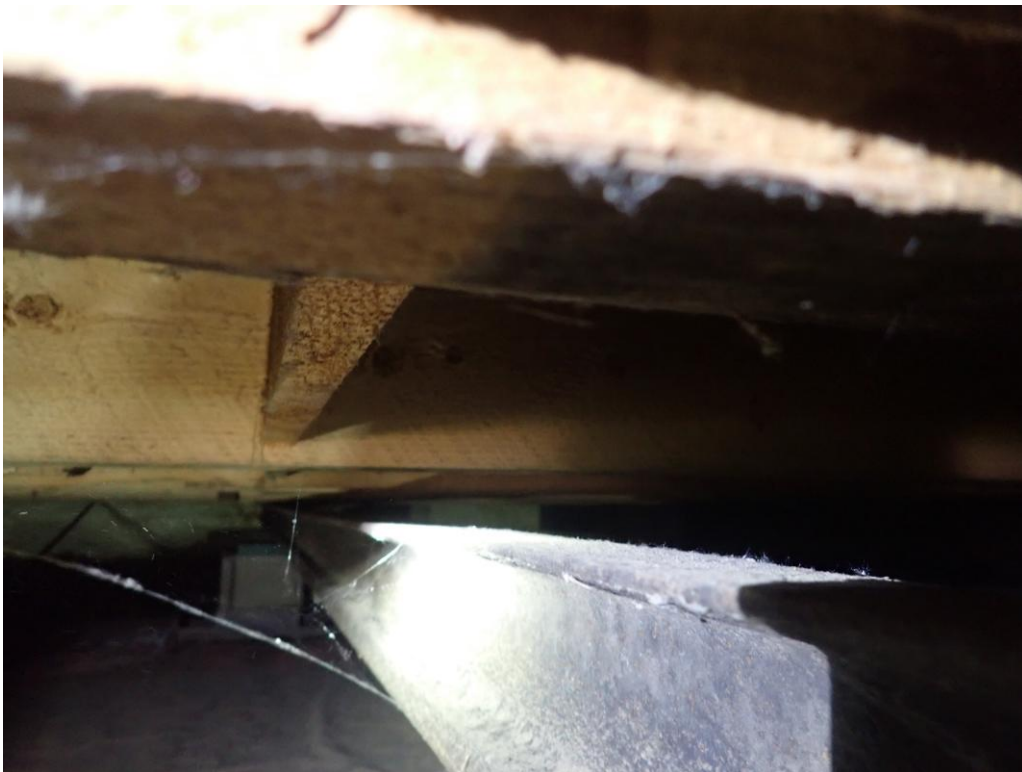
- The original building has a series of concrete and block pedestals as interior foundations for the floor framing. The central timber beam is supported by seven (7) concrete pedestals, and the two (2) rail beams are each supported by five (5) masonry pedestals on concrete footings.
- The masonry pedestals have settled – they are no longer supporting the rail beams and floor framing above. (*Photos 10 & 11*)
- Masonry pedestals P9 through P12 (under the west rail) have varying degrees of cracking and broken pieces noted at the blocks. (*Photos 12 & 13*)
- The stone on top of the masonry pedestal P15 is cracked. (*Photo 14*)
- Spalls were noted at the tops of pedestals P1 and P2. (*Photo 15*)

**Photo 10: Pedestal Settlement – Gap between Rail Beam and Floor Framing (West)**

- c. Replace the block pedestals at the rail beams. It is recommended that a timber system be used in lieu of the blocks that currently exist. Shimming should be installed at the top of the pedestals to ensure the rail beams are supporting the floor joists. Additional shims should be installed at joist locations along the rail beams, between pedestals, so that the floor loading will be transferred to these beams. Due to expansion and contraction due to moisture variations, monitoring of the pedestals and shims should occur, and plans for regular maintenance and reshimming should be anticipated.

The joists are not able to support assembly loading without three interior support lines. If repairs to the pedestals are not made, it would be recommended to limit and post the allowable floor live loading of the building.

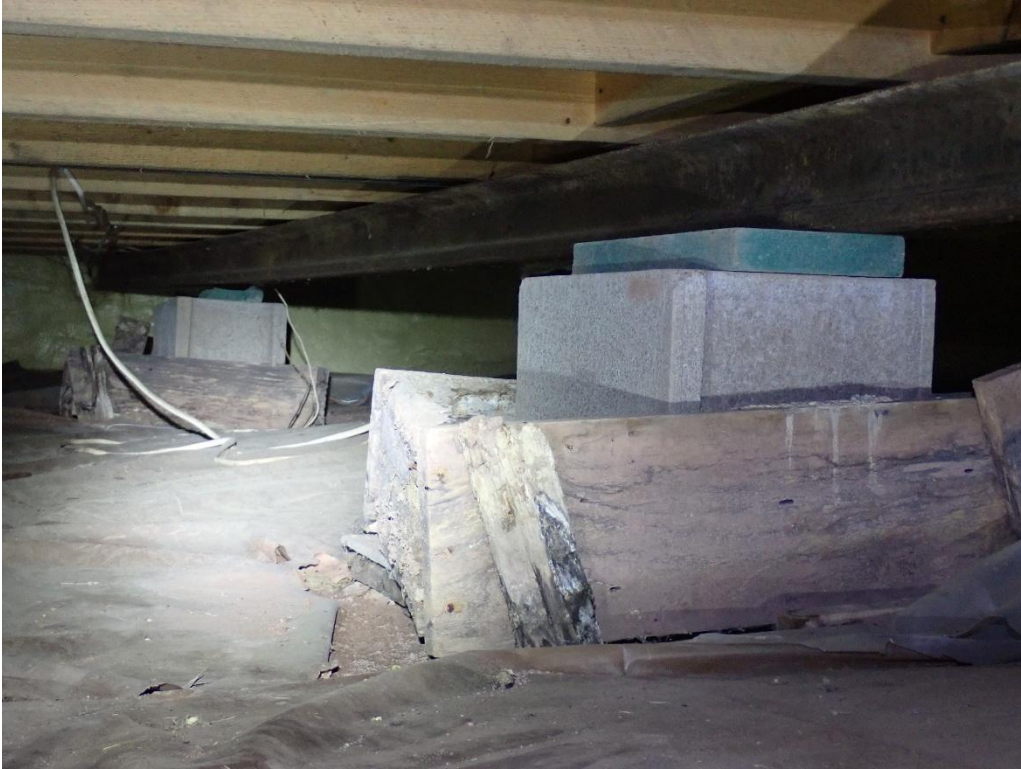
**Photo 11: Pedestal Settlement – Gap between Rail Beam and Floor Framing (East)**

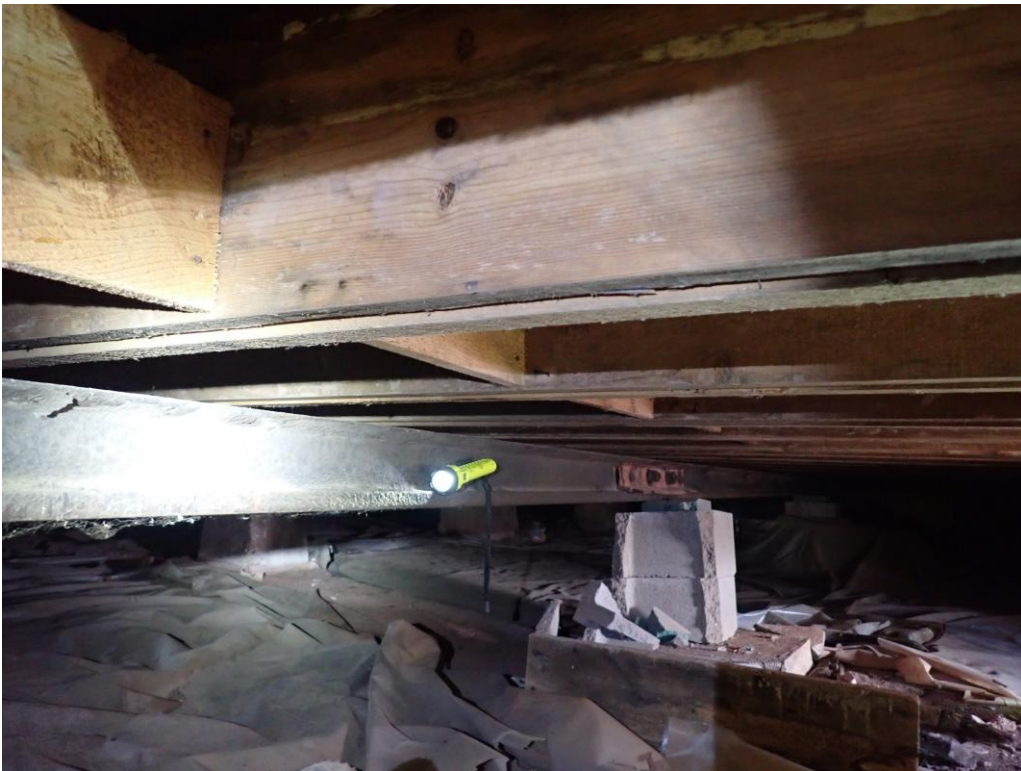
**Photo 12: Pedestal Damage (P10)**

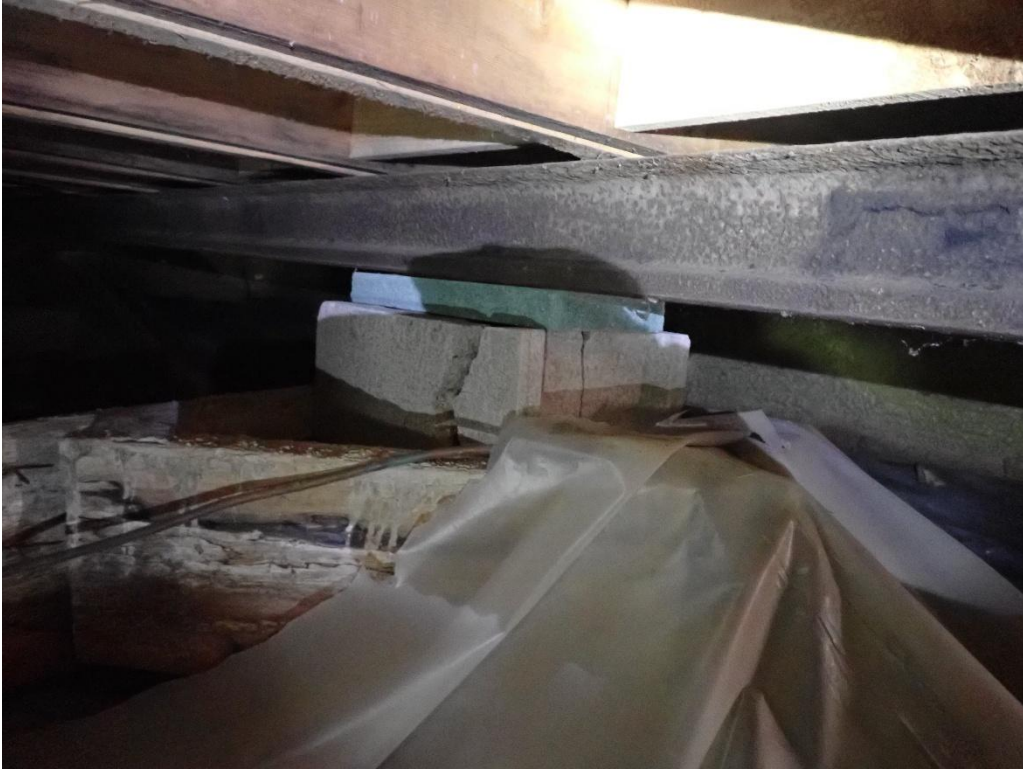
**Photo 13: Pedestal Damage (P11)**

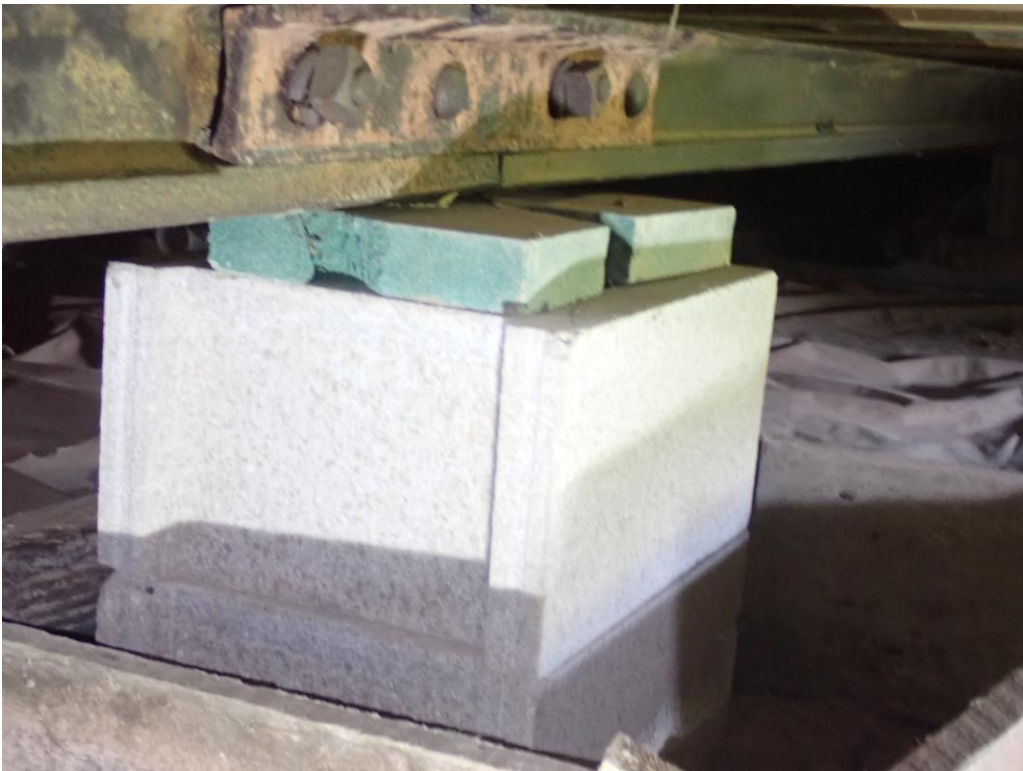
**Photo 14: Pedestal Stone Cracking (P15)**

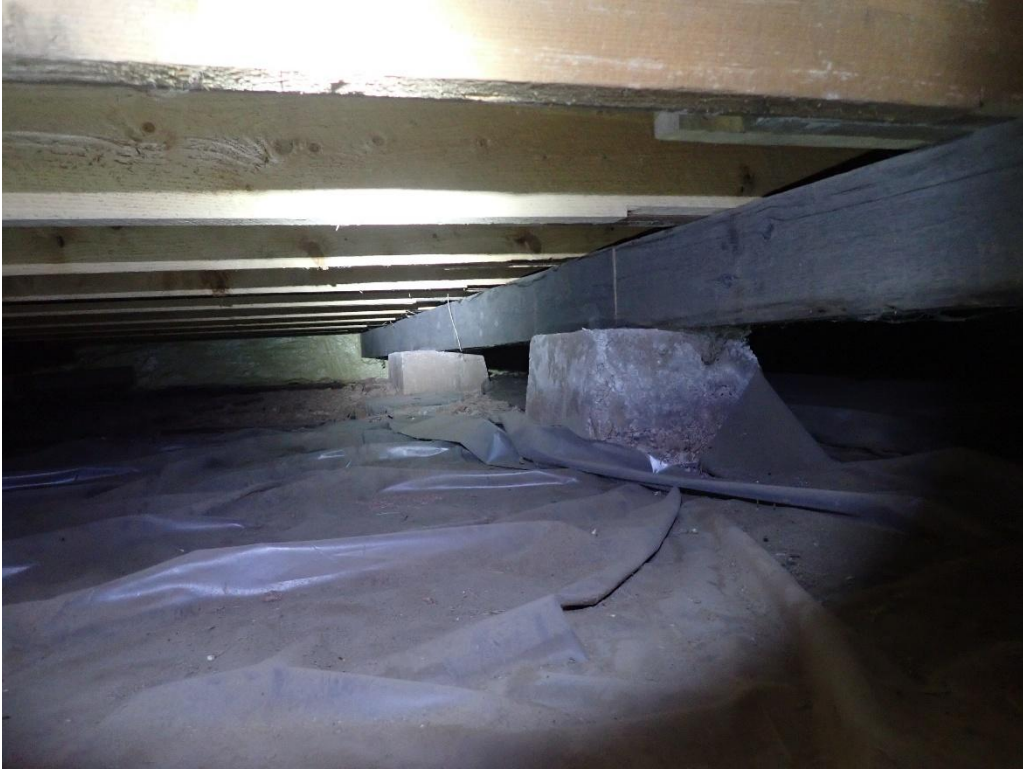
**Photo 15: Spalls at Top of Pedestals P1 and P2**

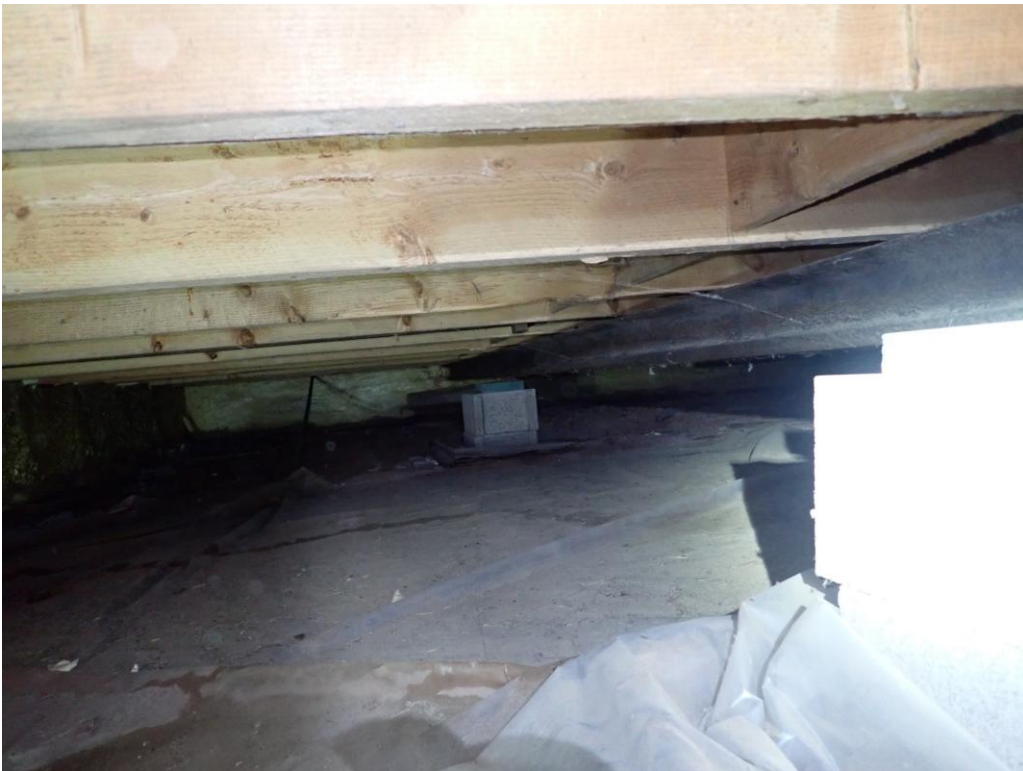
- The floor framing was in generally fair condition. It consists of double 2x12's spanning half the floor span from east to west, with a central 6x8 timber beam running north to south, and timber decking for the subfloor. (*Photos 16-18*)
- The southern most timber beam has been sistered with additional timber framing on each side – from P6 to P7. (*Photo 19*)
- The timber beam was sistered between P4 and P5 on the east side. (*Photo 20*)
- A few horizontal checks were noted in the timber beams, the most notable between P5 and P6. (*Photo 21*)
- The rail beams are not currently supporting the floor joists at their midspan as intended, see the foundation section for additional observations related to this.

**Photo 16: Typical Floor Framing Condition (West)**

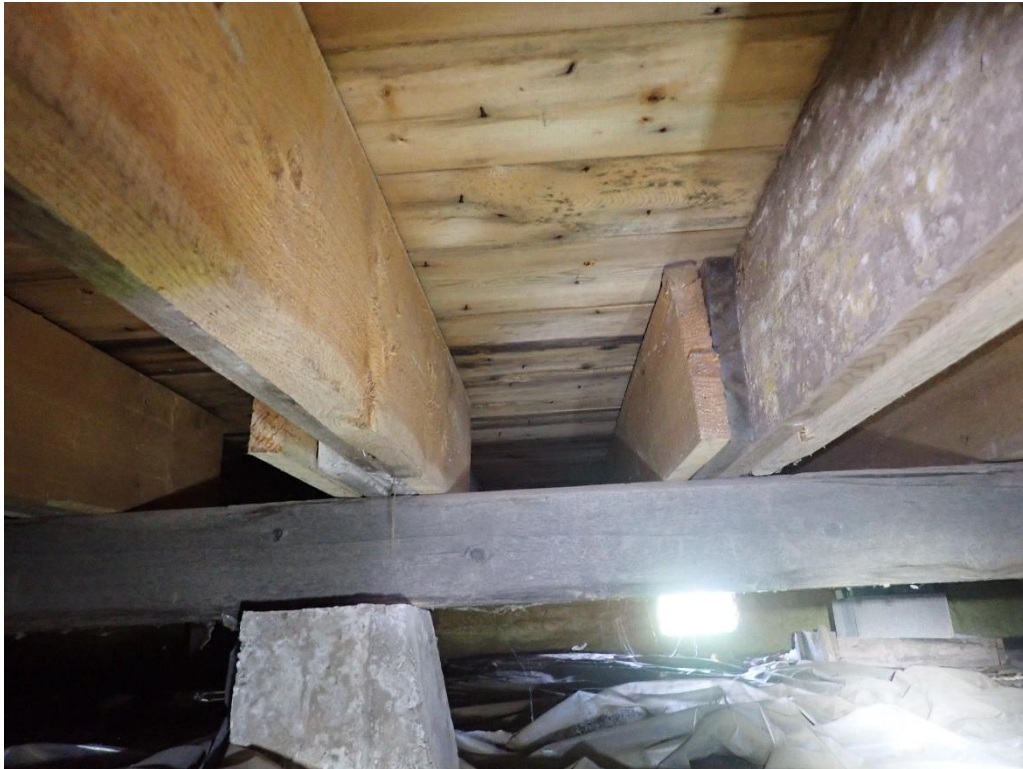
1. Overall, the floor framing appears to be in generally fair to good condition. Checks that were noted in the timber beams do not appear to affect the structural capacity. Water staining at the joists, floor decking, and floor planks indicate water intrusion has occurred, but it appears to have been previously addressed, and does not appear to affect the structural capacity.
2. To restore the floor to its previously reinforced capacity, the pedestals beneath the rail beams should be repaired so that they properly support the rail beams and the floor joists at their midspans.

**Photo 17: Typical Floor Framing Condition – Checks in Timber Beam (West)**

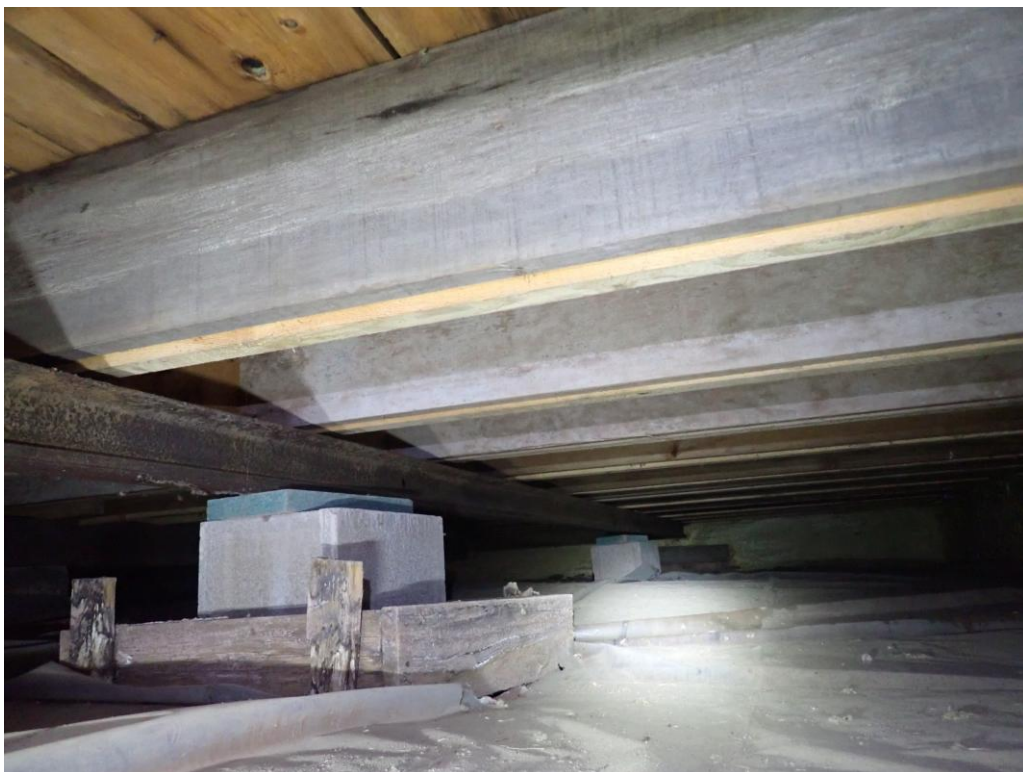
**Photo 18: Typical Floor Framing Condition (East)**

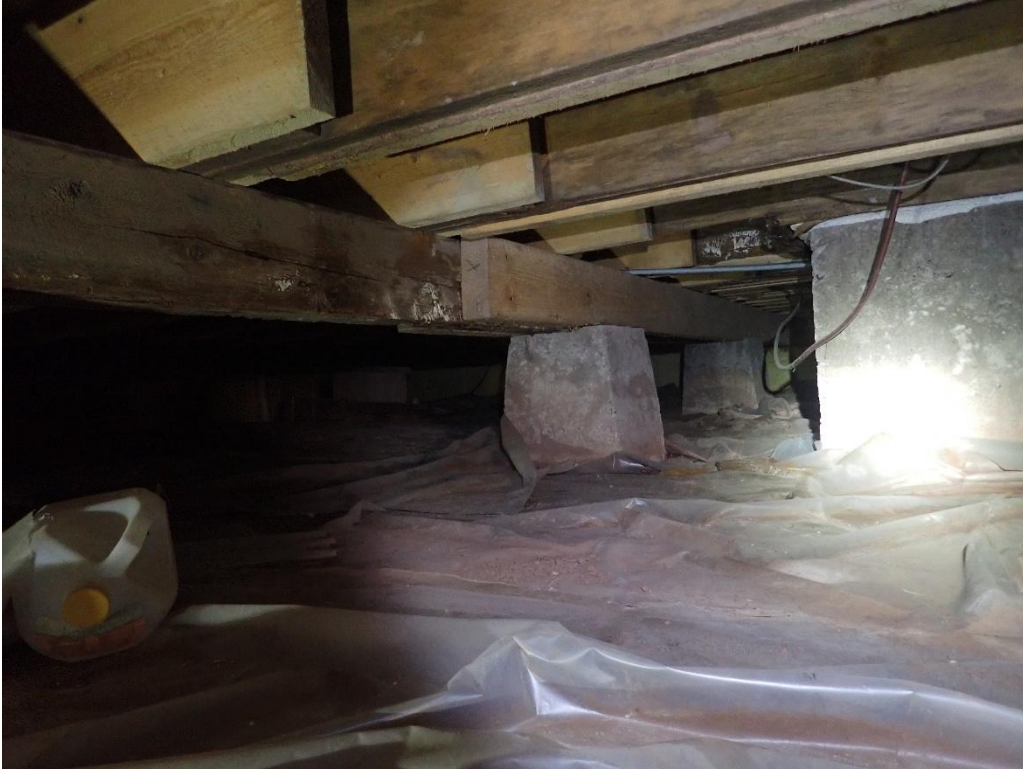
**Photo 19: Sistered Beam (P6-P7)**

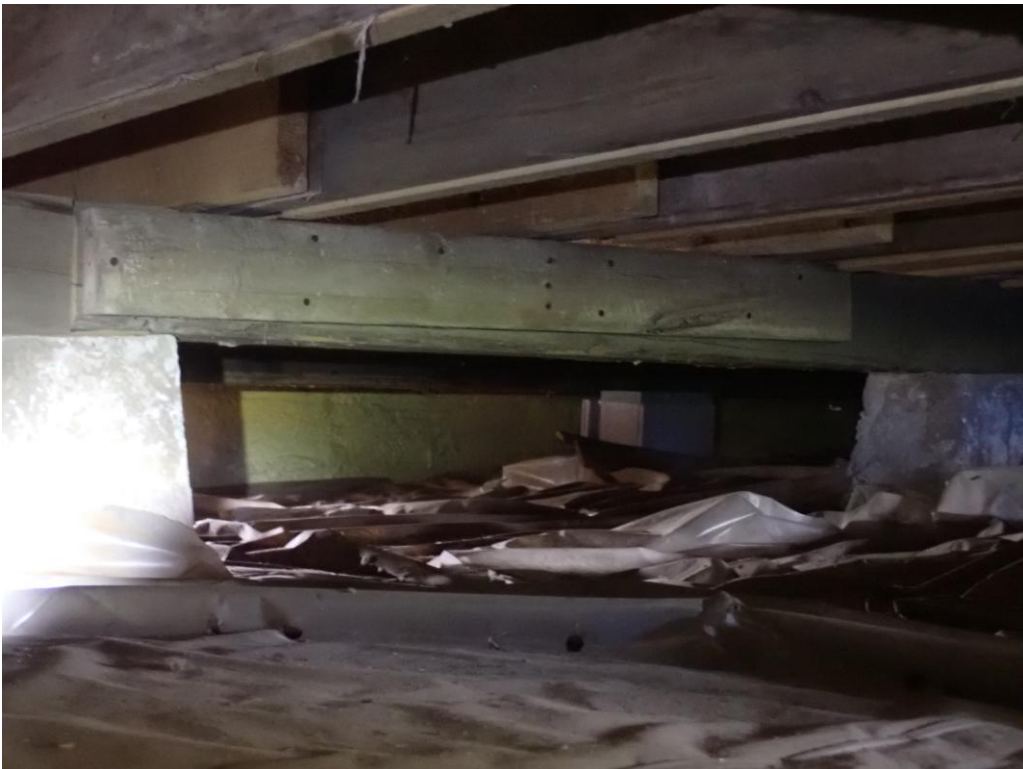
**Photo 20: Sistered Beam (P4-P5)**

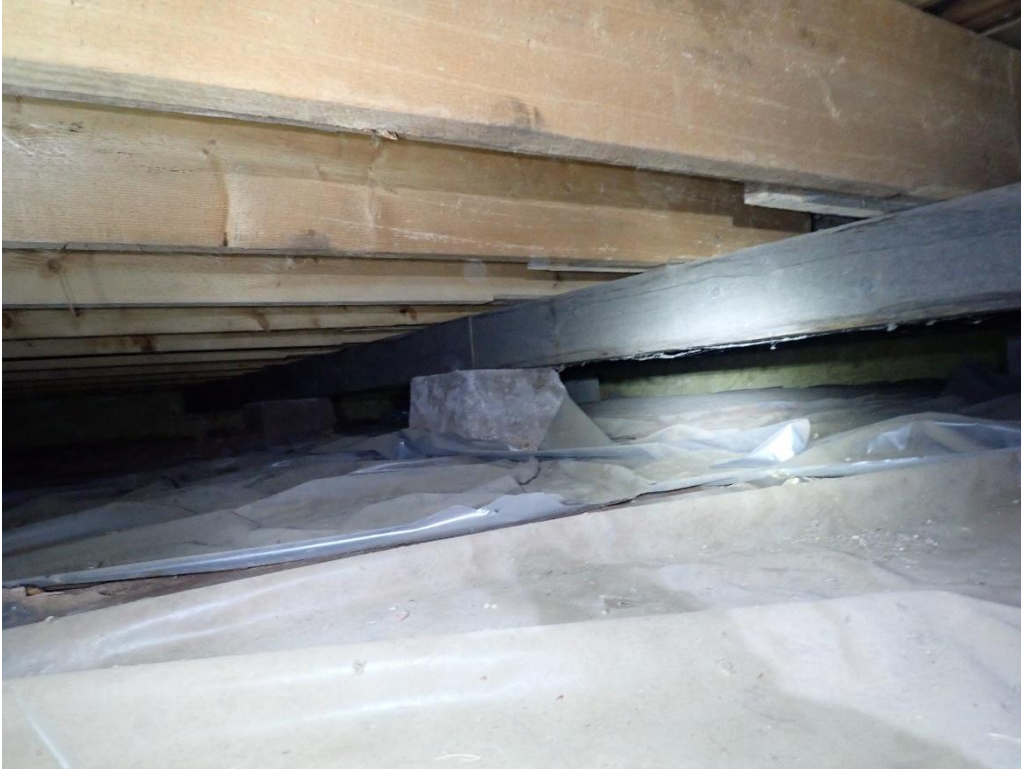
**Photo 21: Checks in Timber Beam**

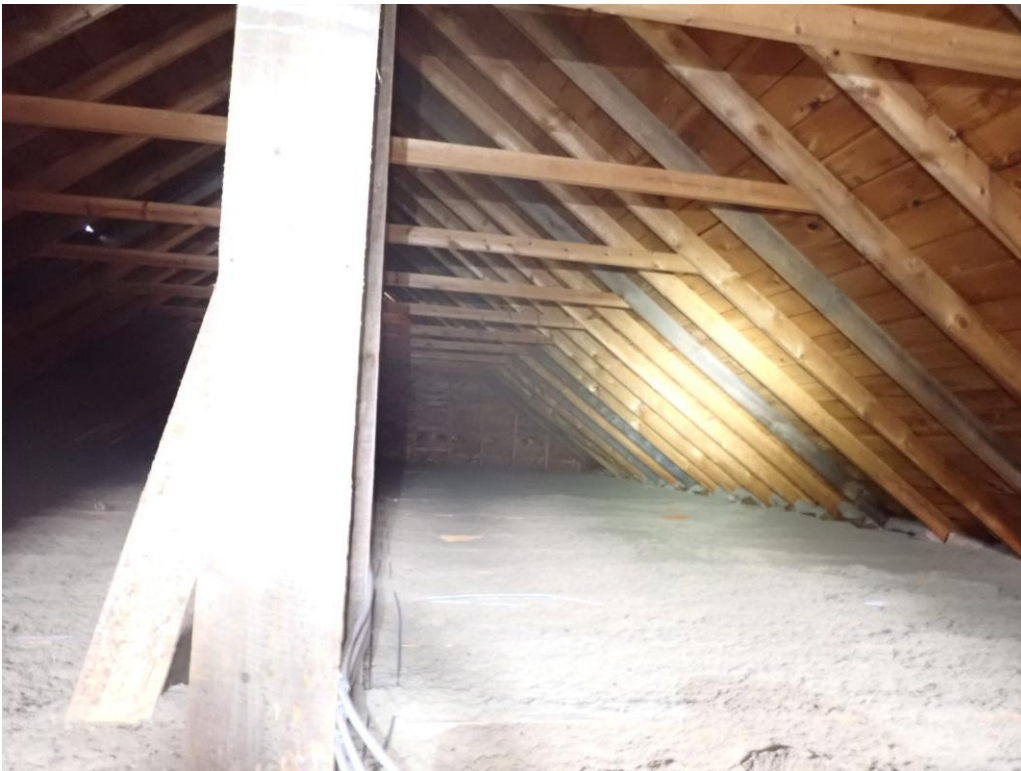
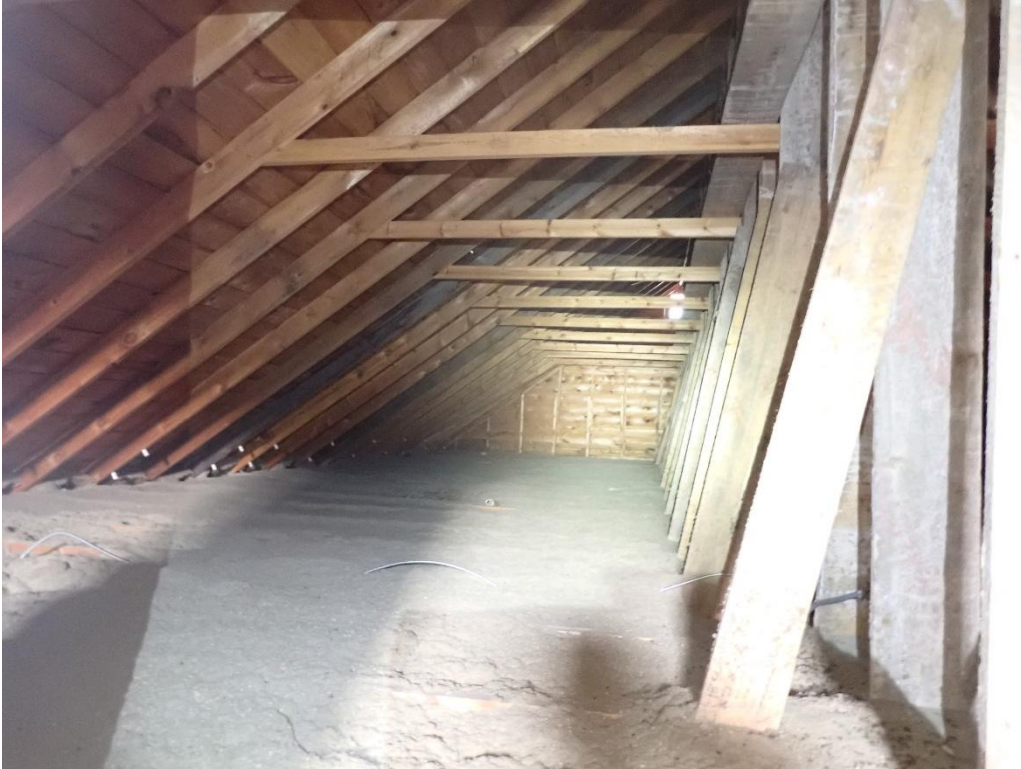
- The original building's attic/roof framing appeared to be in generally fair to good condition and consisted of wood rafters spanning in the east-west direction with plank decking. (*Photos 22 & 23*)
- Areas of moisture staining were noted – most notably at the southeastern area of the roof. (*Photo 24*)

**Photo 22: Roof Framing – Original Building**

**Photo 23: Roof Framing – Original Building**

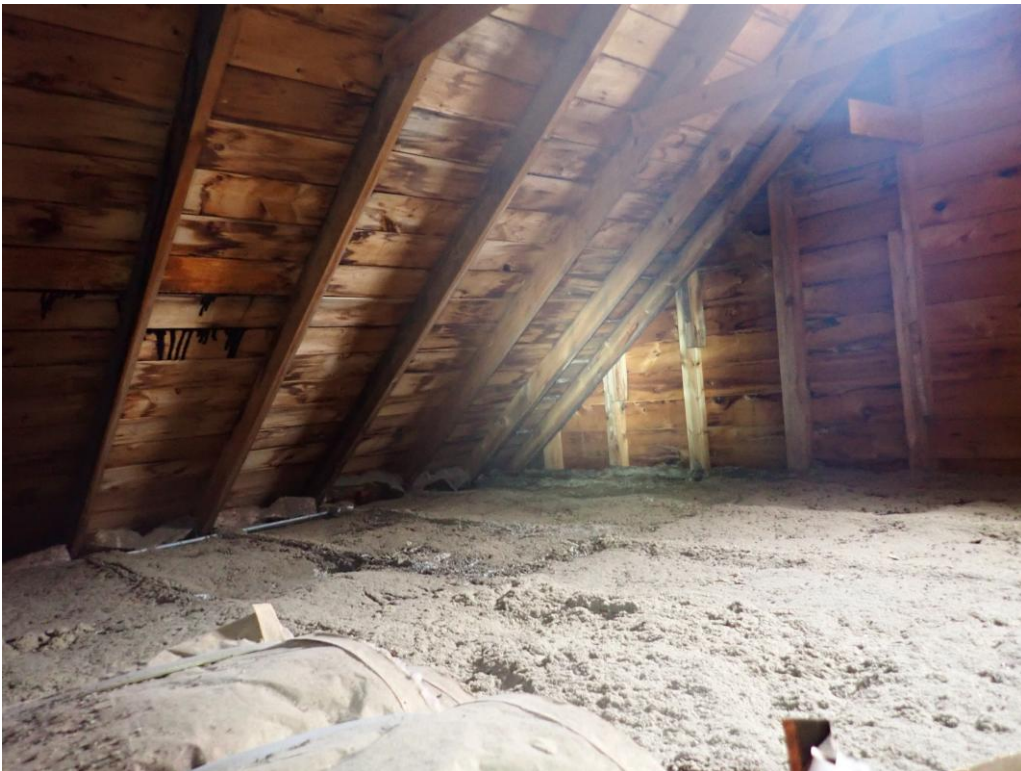
1. The attic and roof framing systems appear to be in fair to good condition. No areas of distress or areas of structural concern were observed.
2. Water staining on roof framing members and decking indicate water intrusion has occurred. Missing or damaged building envelope components, such as shingles or proper sealing around roof penetrations, provide an opportunity for additional water damage.

**Photo 24: Moisture Staining at Roof – Original Building**

2. The following additional repairs and consideration are recommended to address non-structural observations:
  - a. Repair and/or perform maintenance on the building cladding systems, including the shingles and roof covering systems and the deteriorating wood siding.

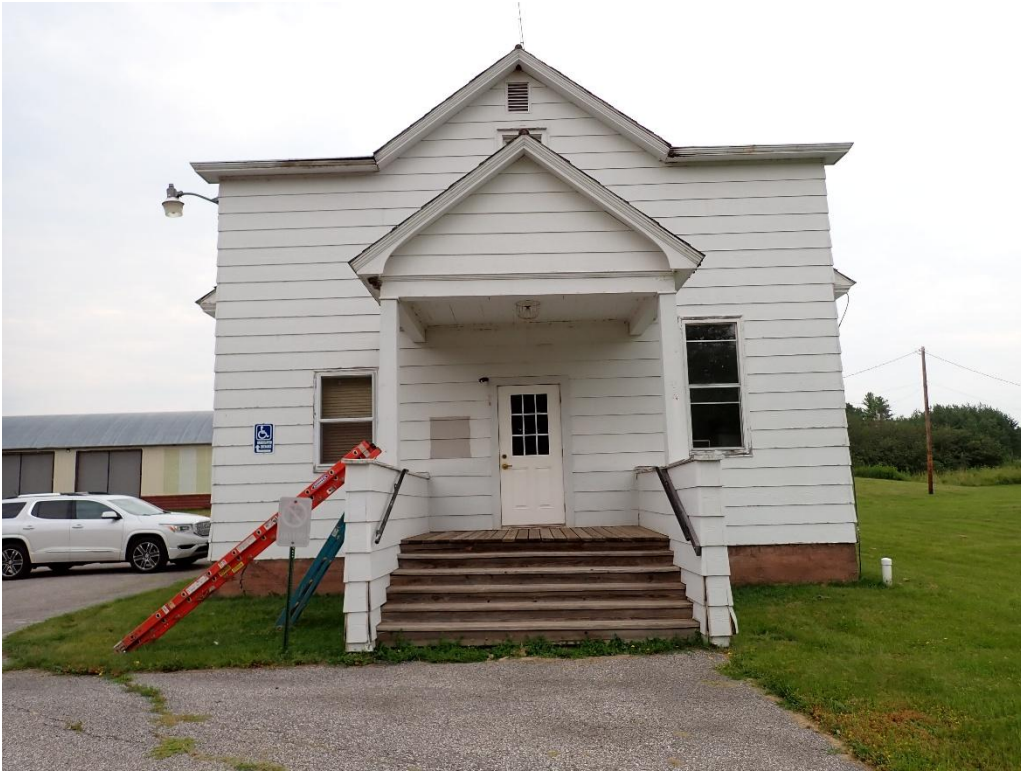
- The porch (roof and floor) is supported at the building's south wall and by two steel posts at the south side of the porch roof. The posts are supported by CMU strip foundations that do not appear to be installed to frost depth. (*Photos 25 & 26*)
- The porch is generally sloping towards the east and towards the north – indicative of frost cycle movement of the non-frost depth foundations. (*Photos 27 & 28*)
- There is no apparent positive attachment from the posts to the CMU foundations

Photo 25: Building Elevation Looking North – Front Entrance Porch

- e. The foundation system for the front porch is inadequate. It is recommended that the porch be temporarily resupported so that new properly sized frost depth foundations can be installed under the posts.

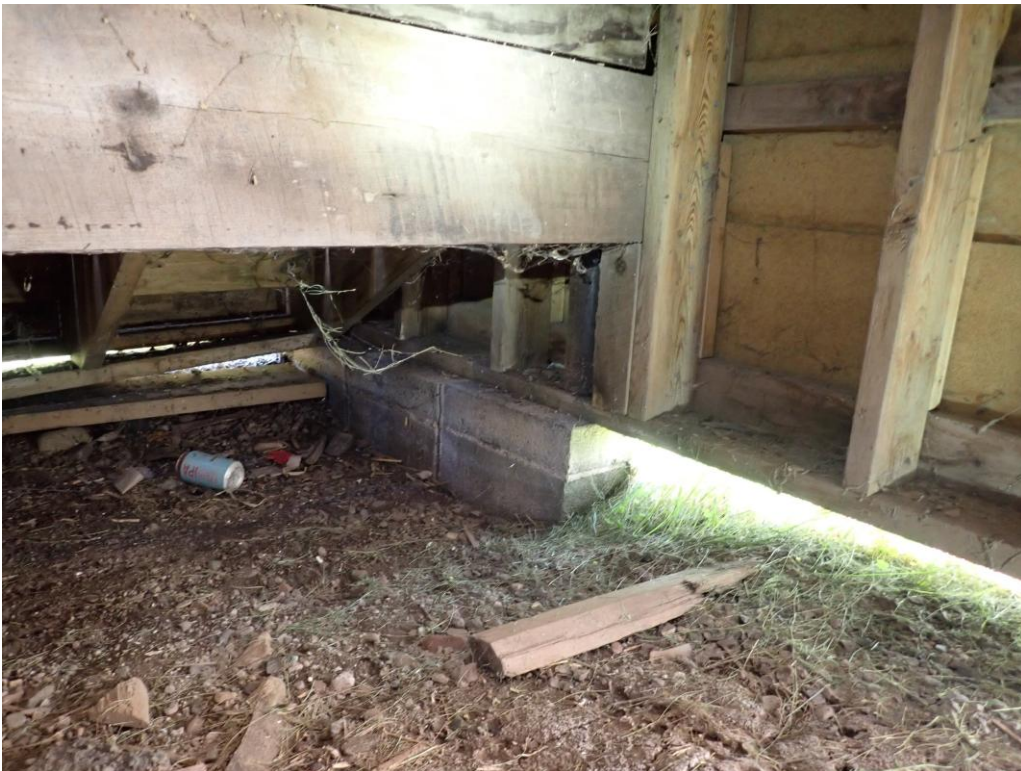
Photo 26: SW Porch Post CMU Foundation

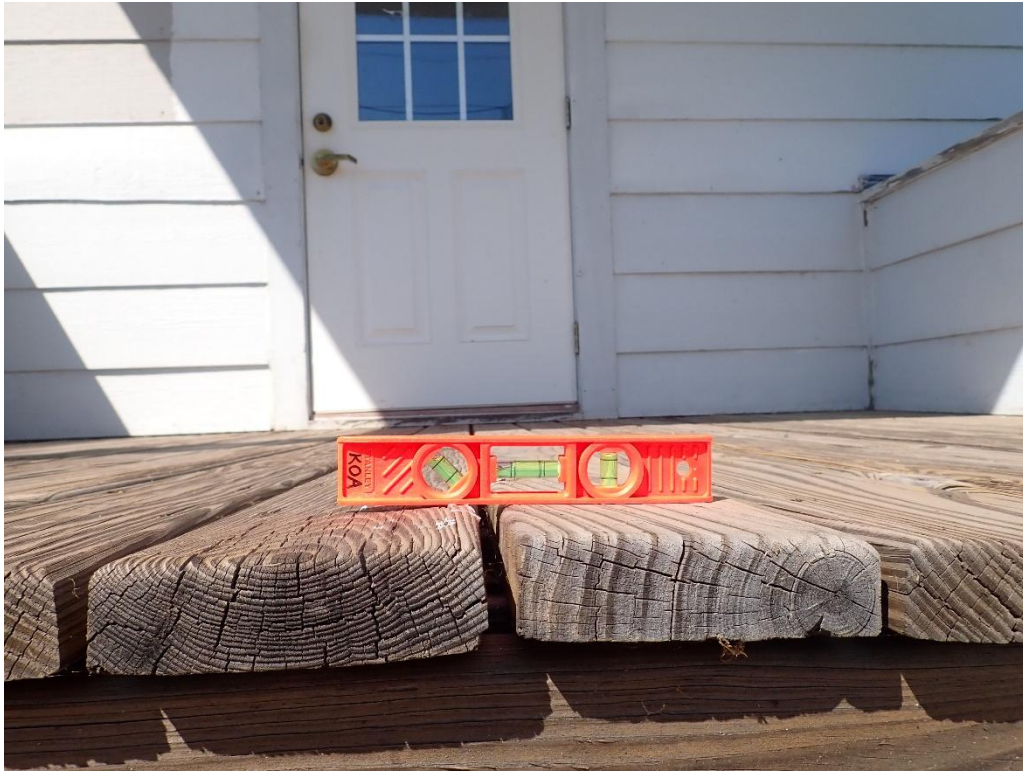
**Photo 27: Porch Sloping Towards East**
