# Silver Creek Town Hall Structural Assessment

**Silver Creek Township  
1891 Town Road, Two Harbors, MN 55616**

August 26, 2025  
KOA No. 251139

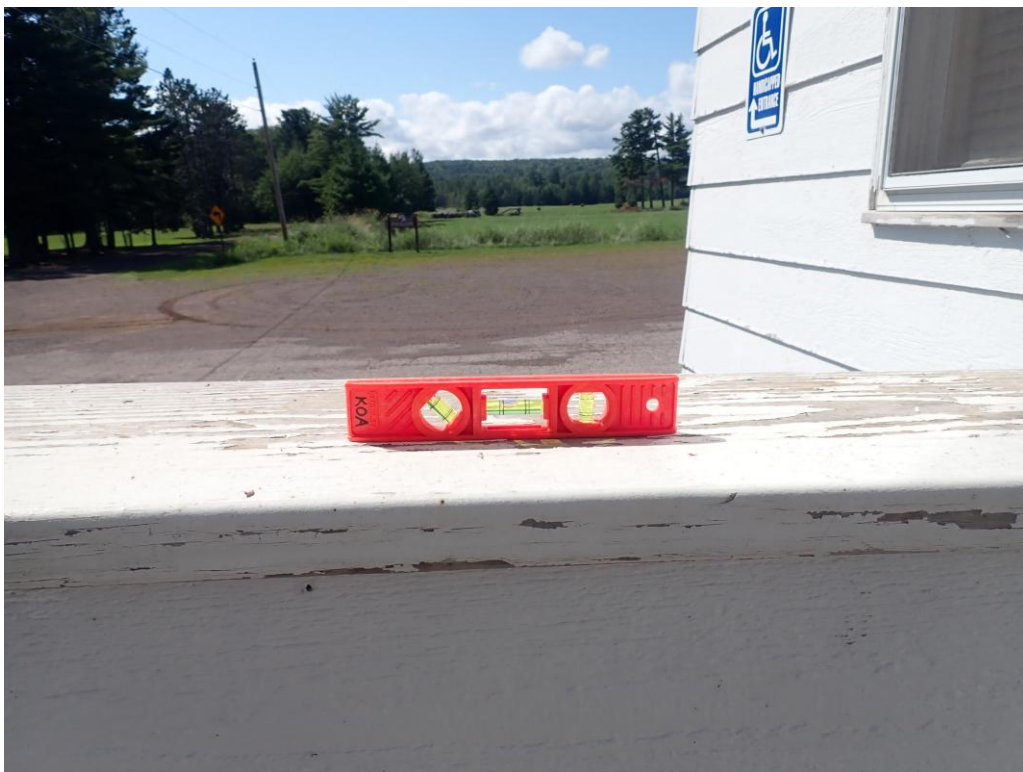
- The porch (roof and floor) is supported at the building's south wall and by two steel posts at the south side of the porch roof. The posts are supported by CMU strip foundations that do not appear to be installed to frost depth. (*Photos 25 & 26*)
- The porch is generally sloping towards the east and towards the north – indicative of frost cycle movement of the non-frost depth foundations. (*Photos 27 & 28*)
- There is no apparent positive attachment from the posts to the CMU foundations

**Photo 28: Porch Sloping Towards North**

- e. The foundation system for the front porch is inadequate. It is recommended that the porch be temporarily resupported so that new properly sized frost depth foundations can be installed under the posts.

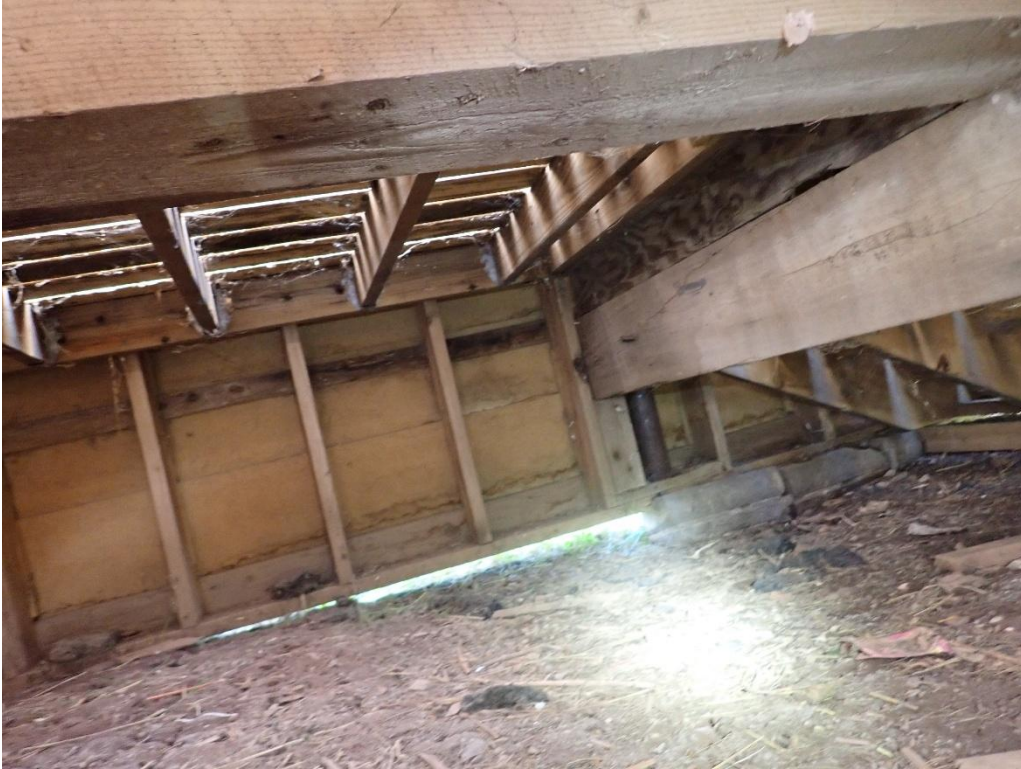
- The eastern post's block foundation is tipping towards the east, and cracking and damage at the masonry joints was noted. *(Photo 29)*

3. The exterior foundation wall of the original building is in generally fair condition. The spalling at the northwest corner of the foundation wall indicates that water seepage may have occurred in this area. A downspout for the gutter system has been installed in this location, and as such, continued water damage at this corner is not anticipated.
4. The exterior foundation wall of the addition is in poor condition and the service life remaining for this system is limited. There are multiple areas with cracking and damaged CMU blocks. The damage seems to indicate that water may have infiltrated the block and that freeze-thaw cycles led to cracking and/or breakage of the CMU.
5. The porch foundation system is in poor condition. There is evidence of frost heaving and movement of the foundations beneath the porch posts.

**Photo 29: Damaged and Tipping East Porch Post Foundation**

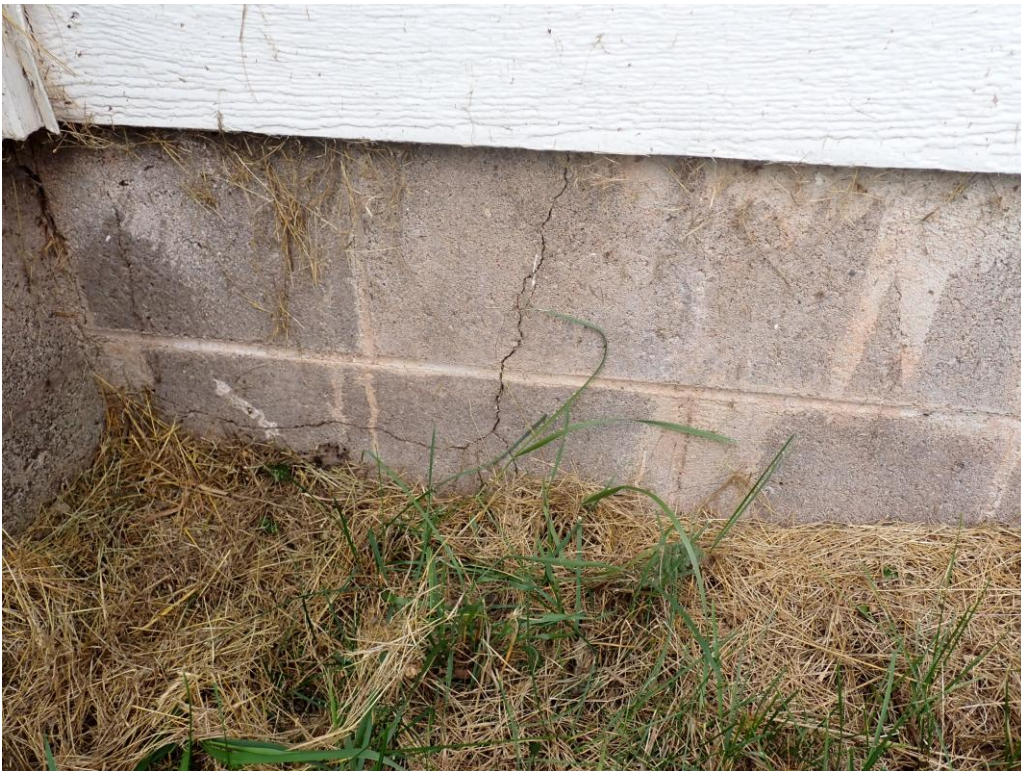
- The addition has a CMU foundation that is in generally poor condition.
- Multiple areas with cracking were observed at the east wall:
  - Cracks through the CMU blocks at the southeast corner *(Photo 30)*

**Photo 30: Addition – Cracking at the SE CMU**

- d. The damage observed at the addition's foundation is significant. It is our recommendation that plans to demolish the existing foundation system be made as the remaining service life of the CMU foundation is limited. Should a new addition be constructed, the foundations should be installed to frost depth or protected from heave.

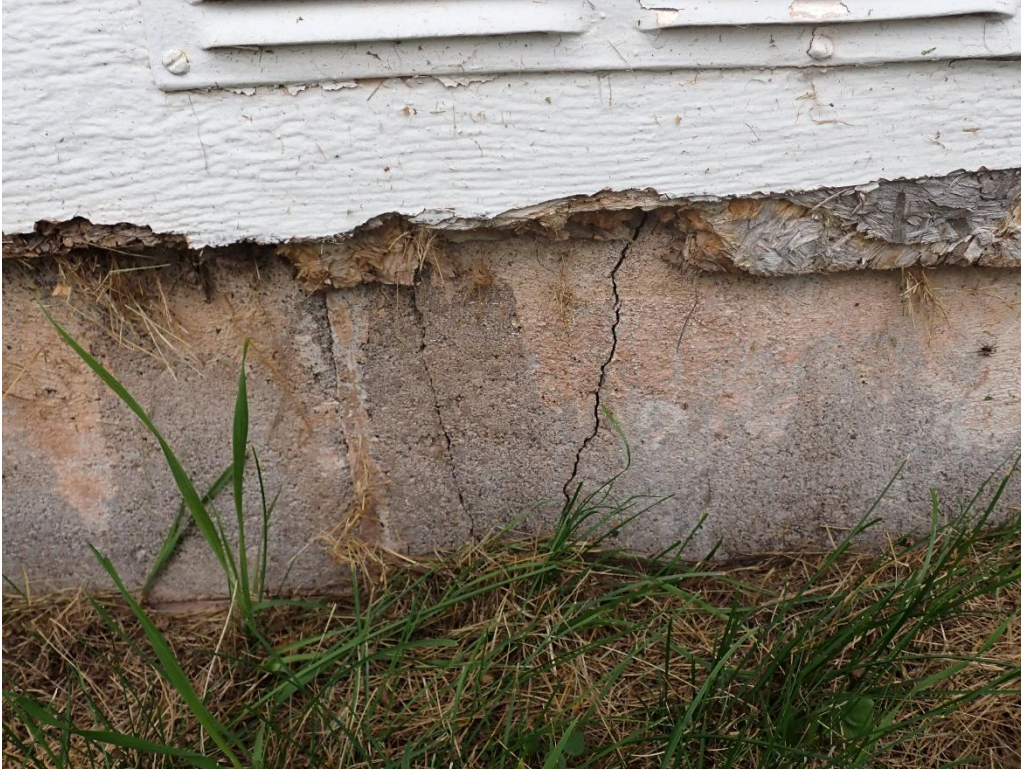
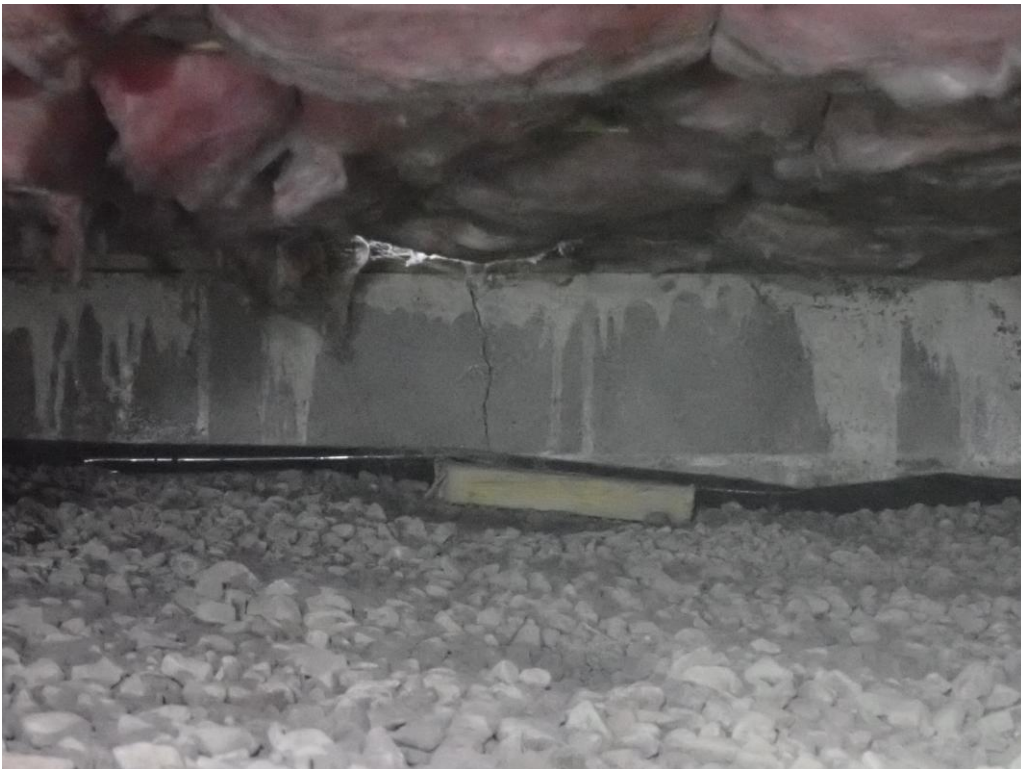
- Vertical cracks through the CMU block noted about 2/3 - 3/4 up the length of the wall (from the southeast corner) *(Photo 31 & 32)*
  - Separation of the CMU at a vertical grout joint *(Photo 33)*

**Photo 31: Addition - Cracking at CMU 2/3-3/4 Along the East CMU Wall**

**Photo 32: Addition - Cracking at CMU 2/3-3/4 Along the East CMU Wall**

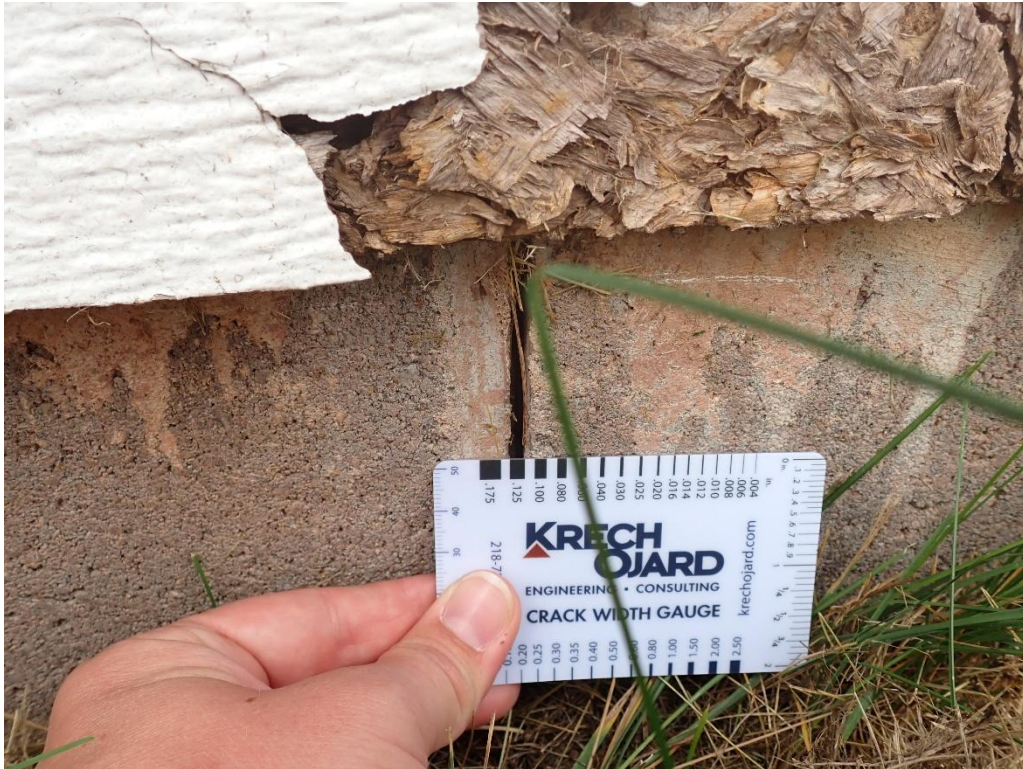
**Photo 33: Addition – Separation at CMU Vertical Grout Joint at East Wall**

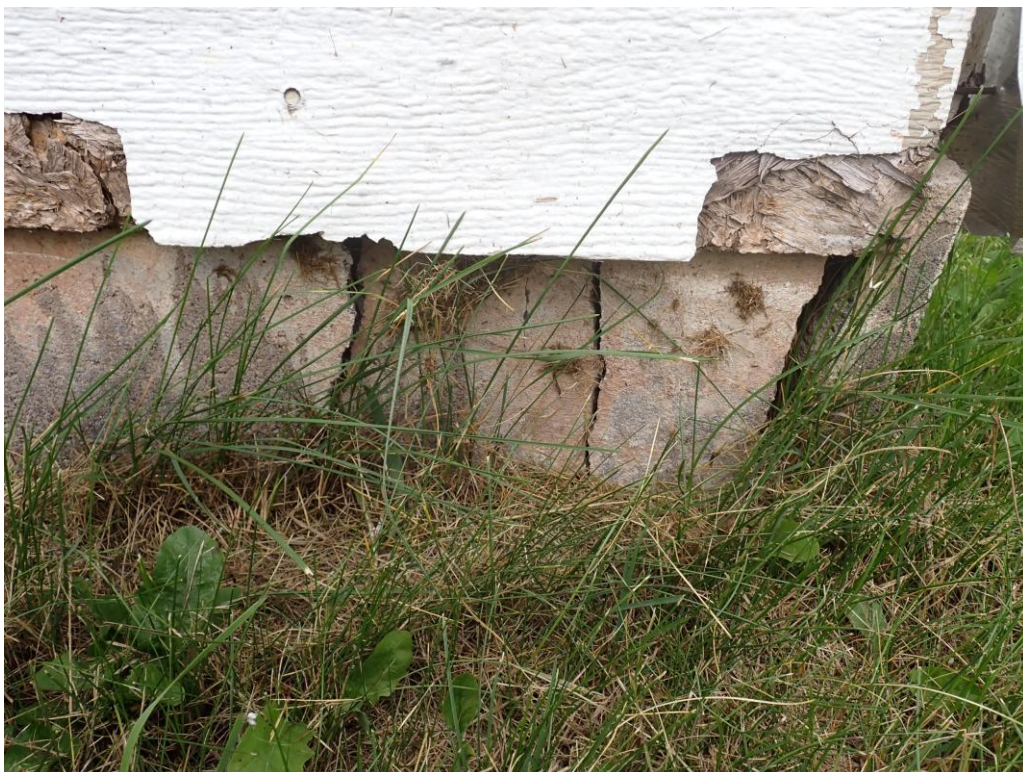
- Multiple vertical cracks and broken CMU noted at the northeastern corner *(Photo 34)*
- Multiple areas with cracking were observed at the north wall:

**Photo 34: Addition – Cracking and Broken CMU Block at the NE Corner**

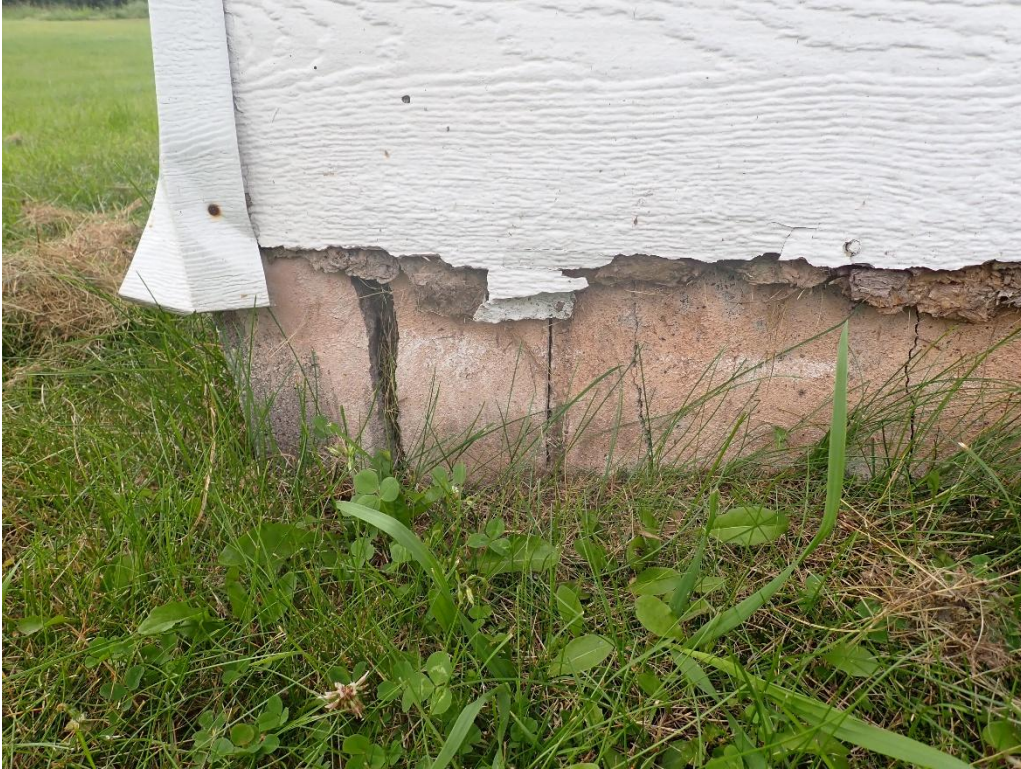
- The CMU block at the northeast corner has broken, and there is additional cracking in the north wall near the corner *(Photo 35)*
  - Vertical cracks and separation were noted at the west corner *(Photo 36)*

**Photo 35: Addition – Cracking and Broken CMU Block at the NE Corner**

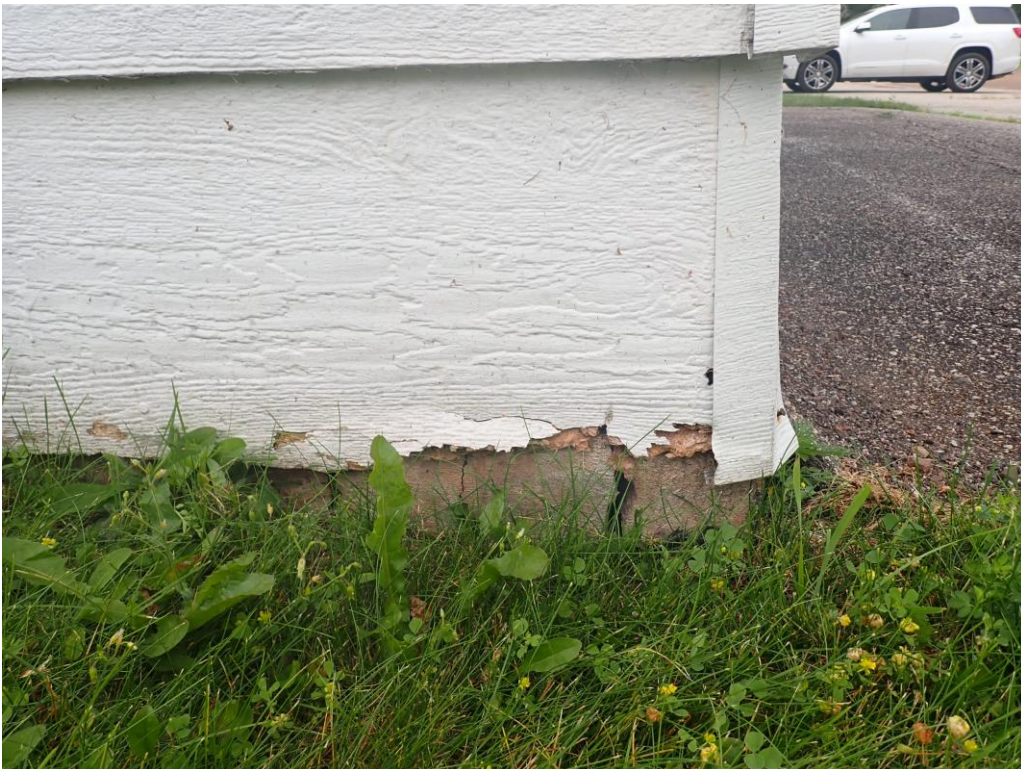
**Photo 36: Addition – Cracking and Broken CMU Block at the NW Corner**

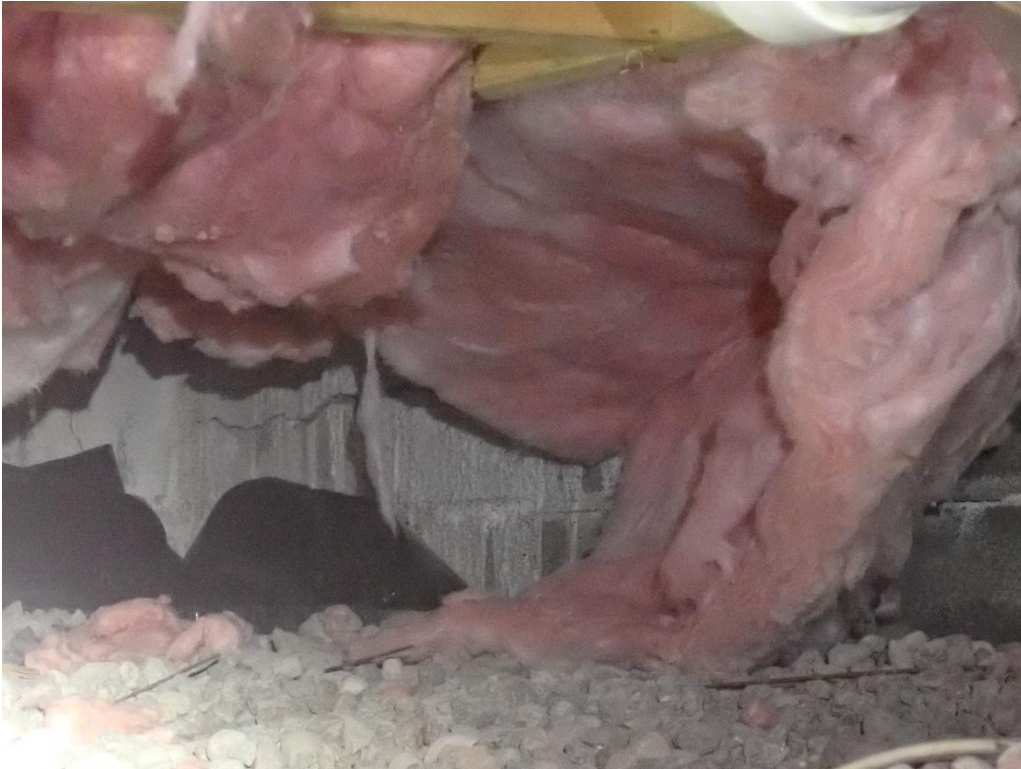
- A horizontal crack through the CMU blocks was noted starting at the southwest corner and running about half the length of the wall *(Photos 37 & 38)*

**Photo 37: Addition – Horizontal Cracking through the CMU at the West Wall**

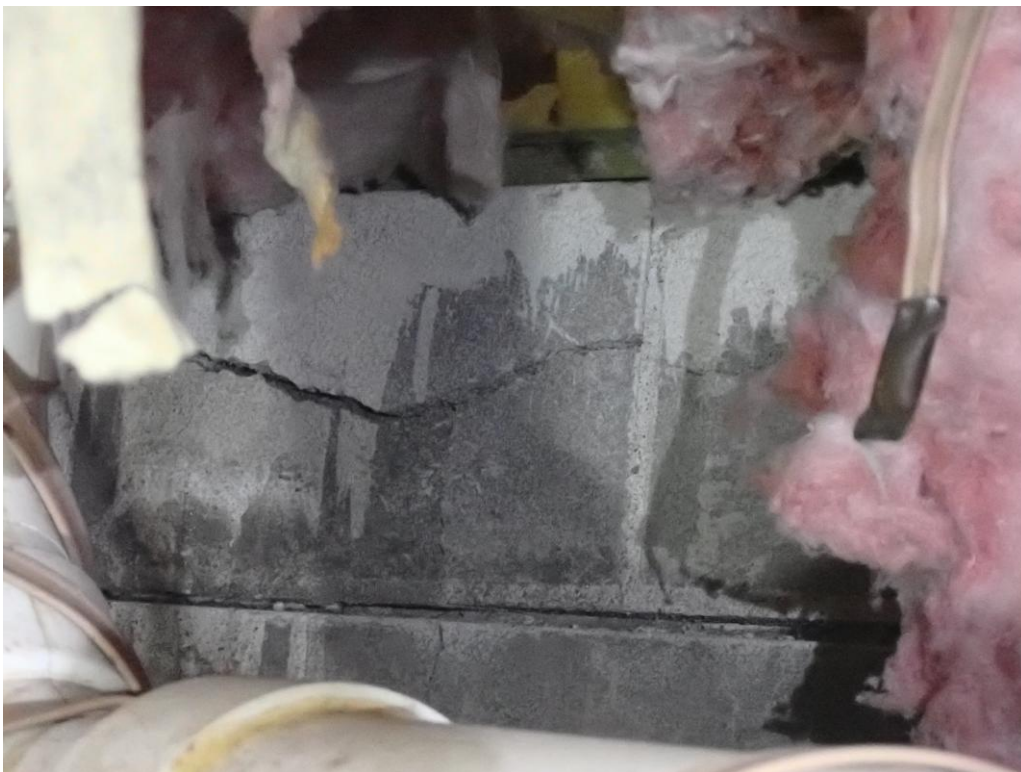
- There is cracking and horizontal separation noted along the CMU bed joint for the northern 3/4 of the wall *(Photos 38 & 39)*
  - Vertical cracks through the CMU and at the CMU head joints were noted in the midspan of the wall *(Photos 39 & 40)*

**Photo 38: Addition – Horizontal Cracking through the CMU and at CMU Joint at the West Wall**

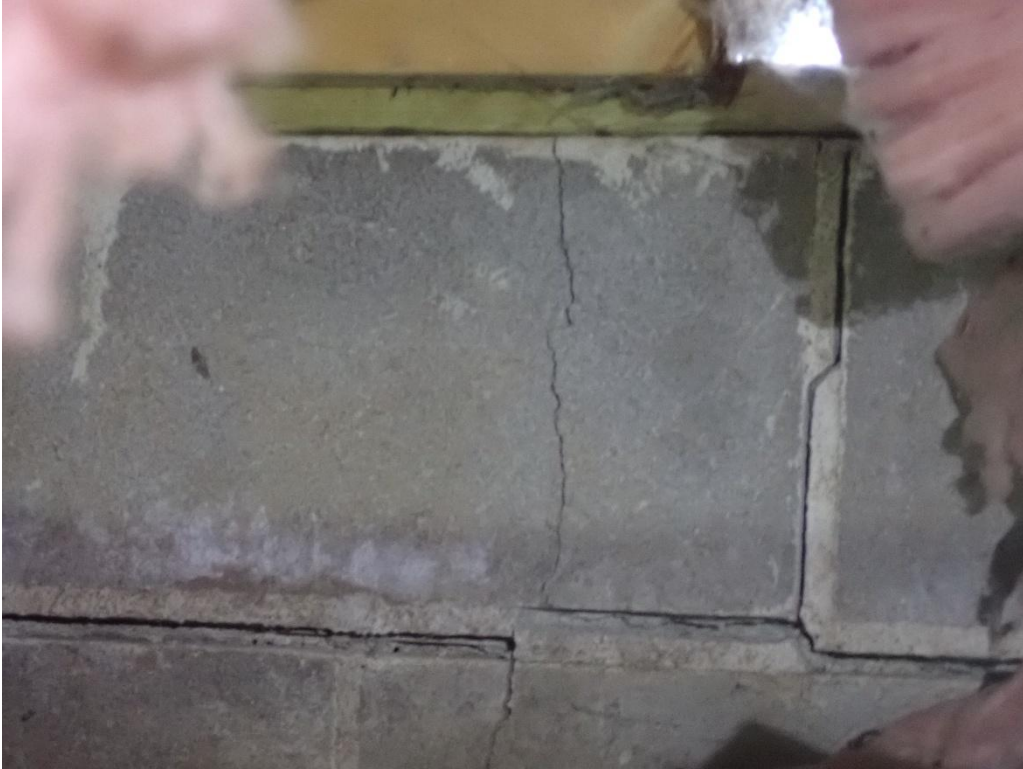
**Photo 39: Addition – Vertical and Horizontal Cracking in CMU and Joints at the West Wall**

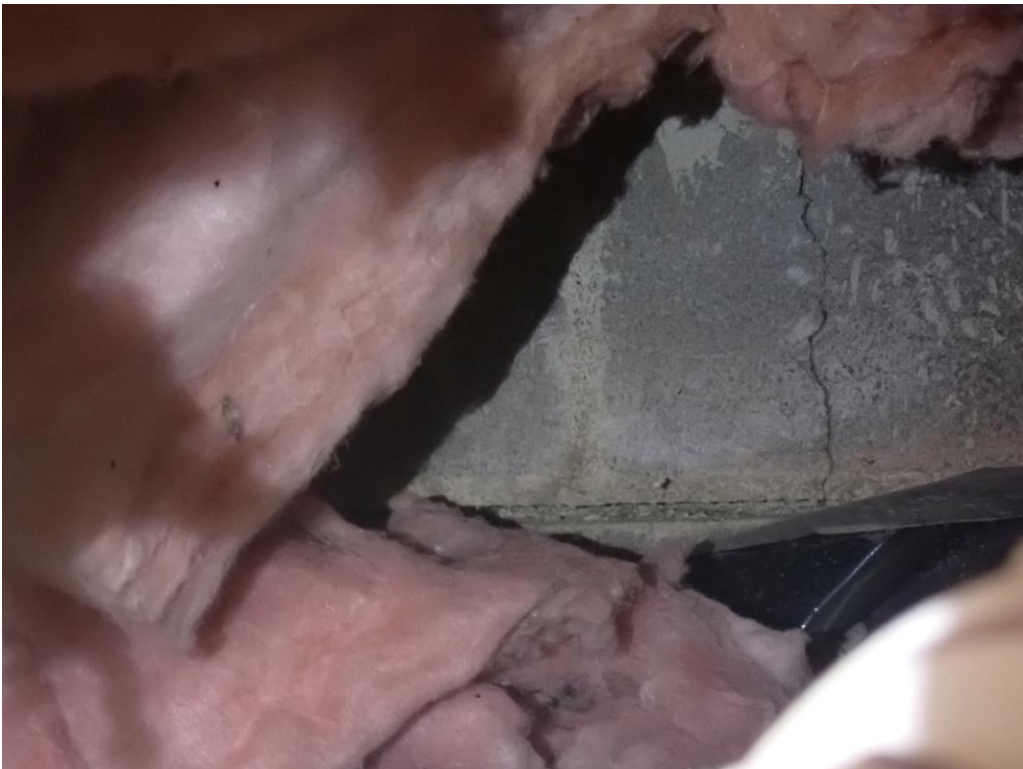
**Photo 40: Addition – Vertical and Horizontal Cracking in CMU and Joints at the West Wall**

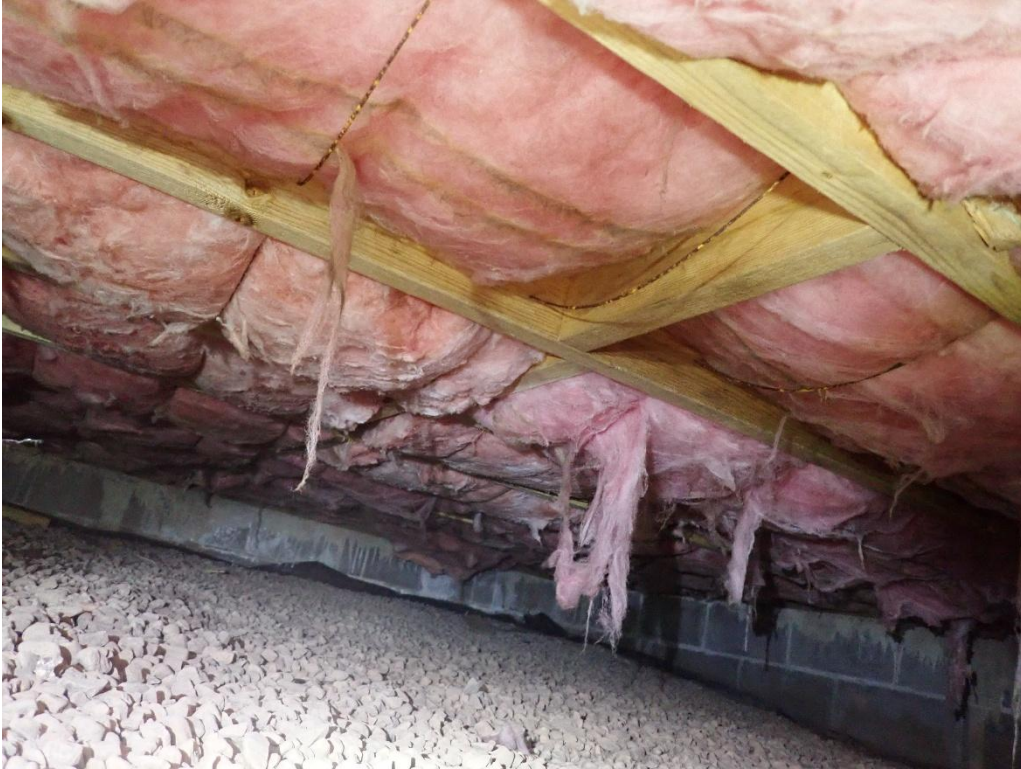
- The floor framing was in generally fair to good condition and consisted of wood joists and plywood decking. *(Photo 41)*
- Local areas of moisture staining were noted in the plywood panels. *(Photo 42)*

**Photo 41: Addition – Typical Floor Framing**

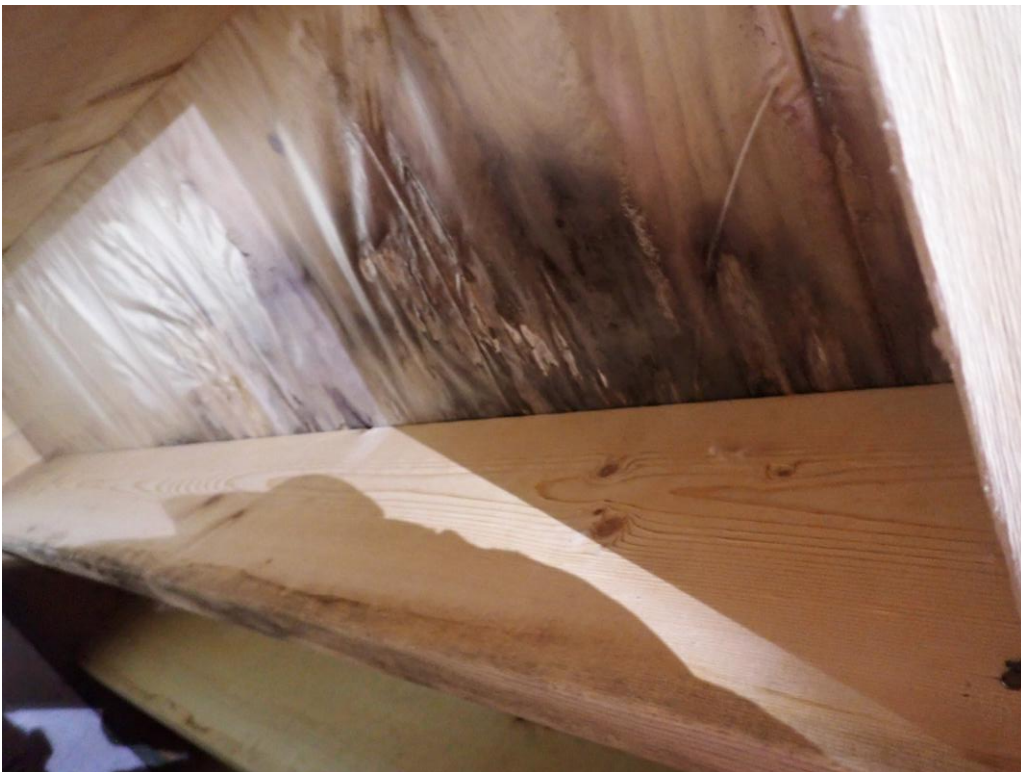
**Photo 42: Addition – Moisture Staining in Floor Decking**

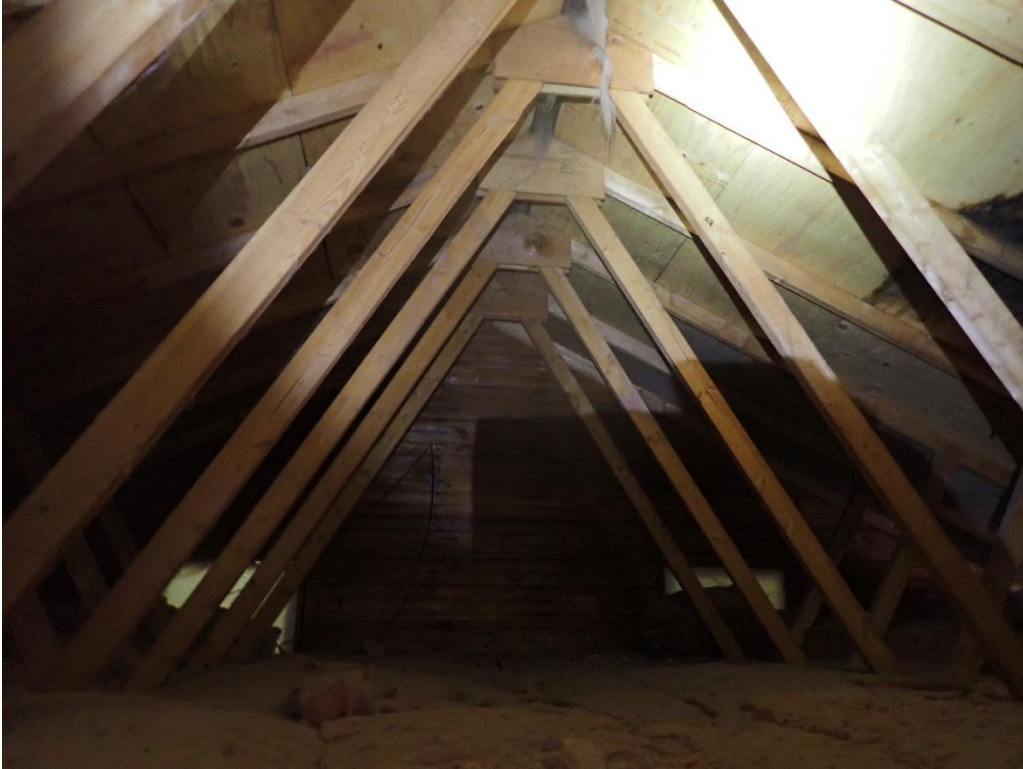
- The addition's attic/roof framing appeared to be in generally good condition and consisted of wood rafters spanning in the east-west direction with plywood decking. *(Photo 43)*
- Moisture staining was noted at the western decking, primarily noted at the northern half. *(Photo 44)*
- A local area of moisture staining was observed at the east decking.

**Photo 43: Addition – Roof Framing Typical Condition**

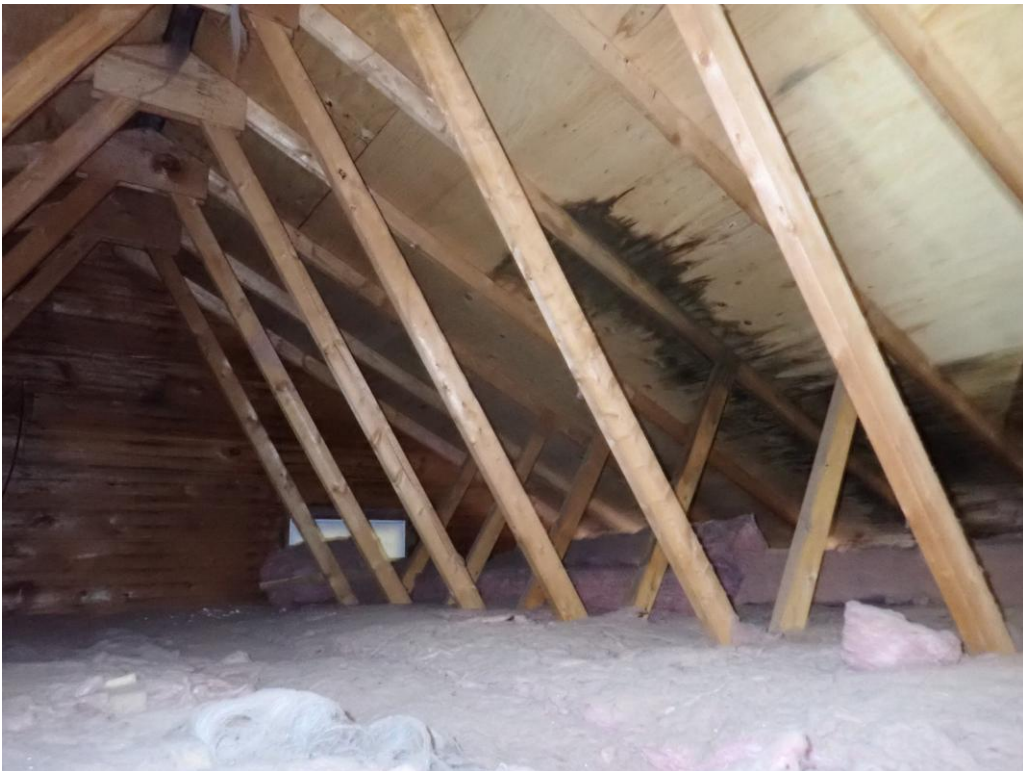
**Photo 44: Addition – Attic Roof Moisture Staining at West Decking**

2. The following additional repairs and consideration are recommended to address non-structural observations:
  - a. Repair and/or perform maintenance on the building cladding systems, including the shingles and roof covering systems and the deteriorating wood siding.

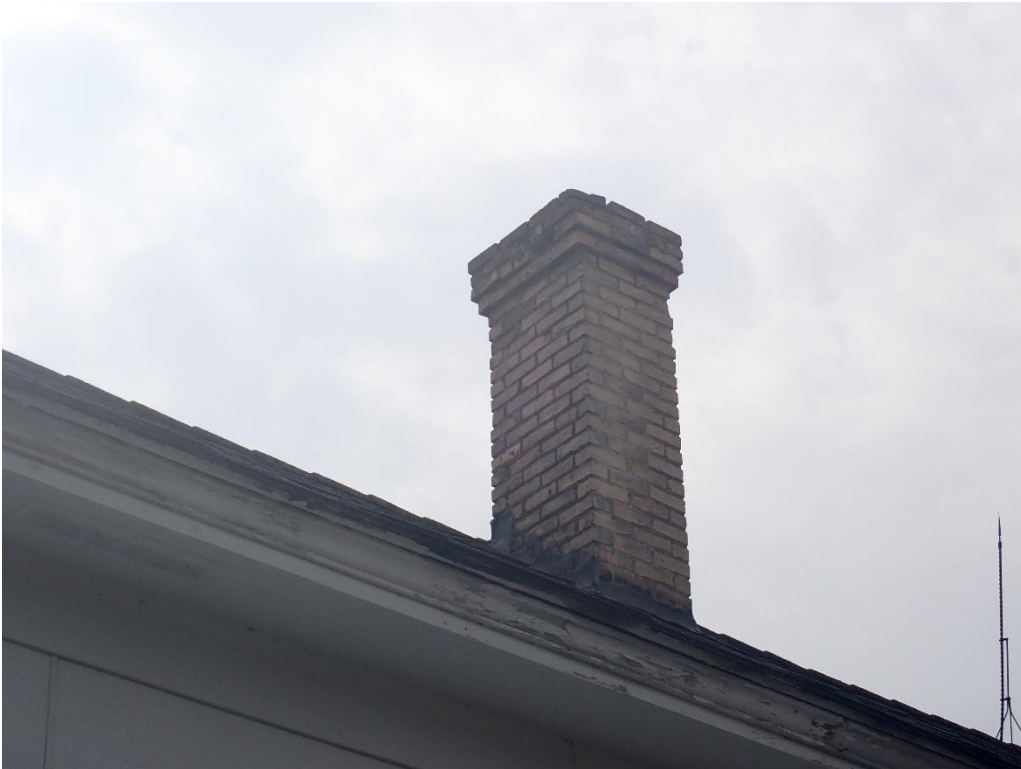
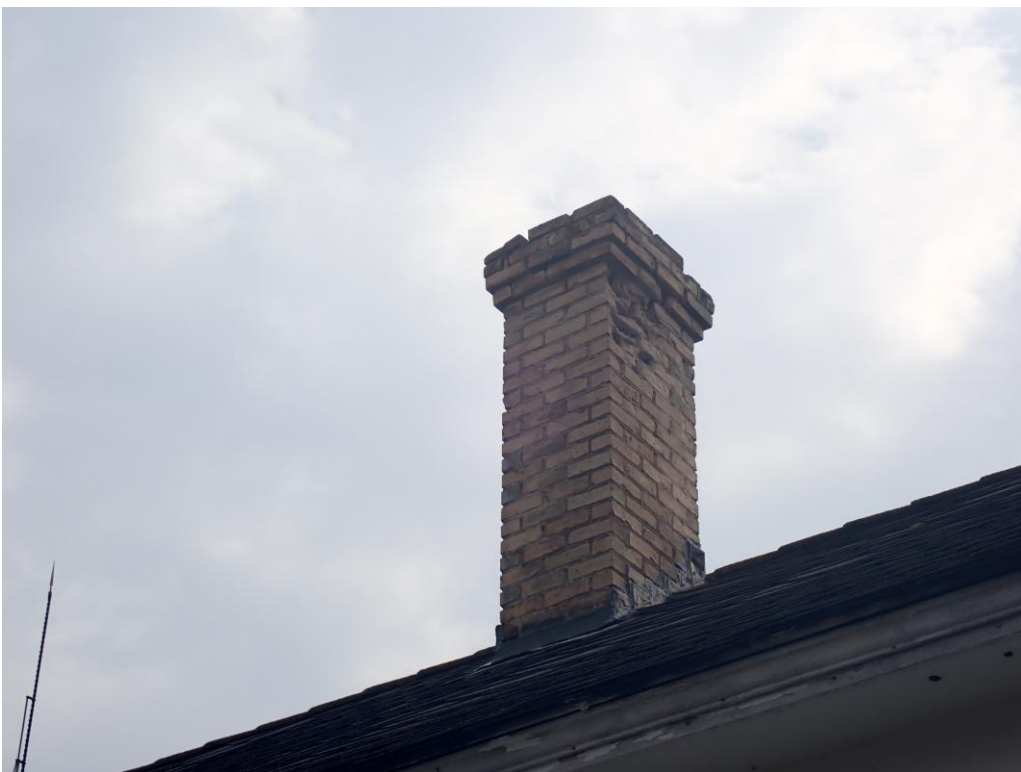
- The chimney above the roof has lost multiple bricks and it appears that several more are loose; most notable at the south face, also noted at the north face. *(Photos 45 & 46)*
- A kitchen drainpipe that discharges to the exterior of the east building wall is cracked and no longer functioning properly. *(Photos 8 & 45)*
- The roof systems (shingles and membrane) have areas of deterioration and failure with the most notable deterioration being located at the north end of the original building roof. *(Photo 46)*
- The wood siding is beyond its useful life. *(Photo 47)*

**Photo 45: Chimney – Looking SE**

**Photo 46: Chimney – Looking NE**

- b. Repair the damaged kitchen water drainage pipe at the east wall to prevent water from discharging to grade.
  - c. Repair or replace the chimney extension above the roof to prevent further damage and/or loss of bricks.

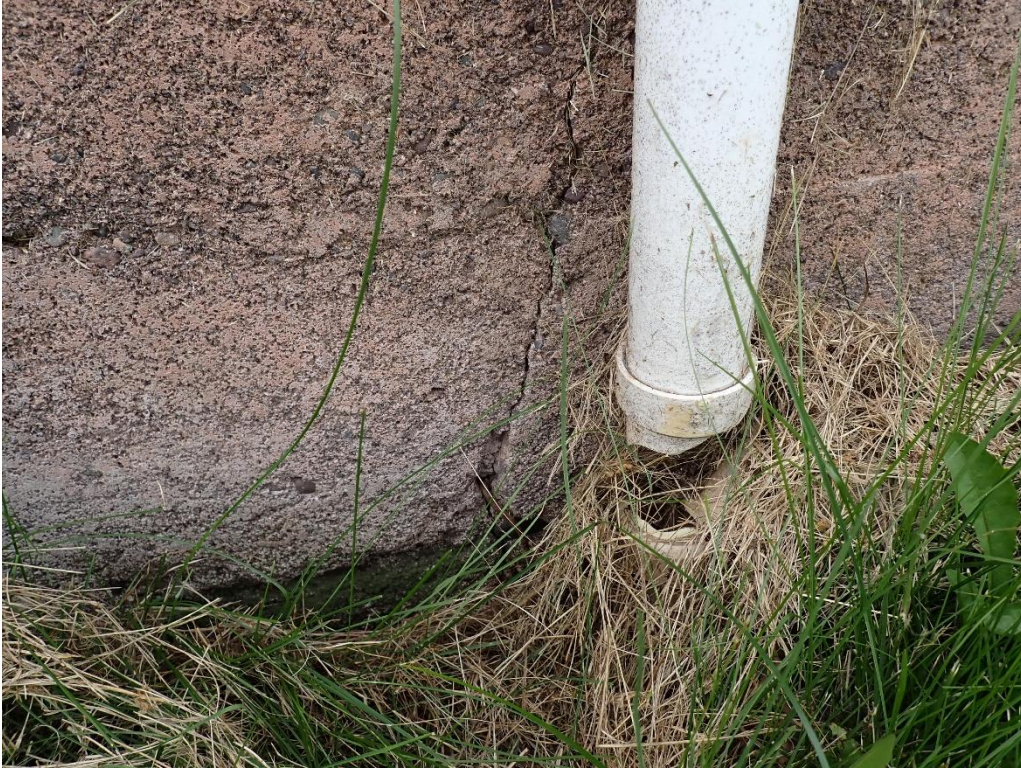
**Photo 45: Broken Drain Pipe at East Wall (Outside of Kitchen)**

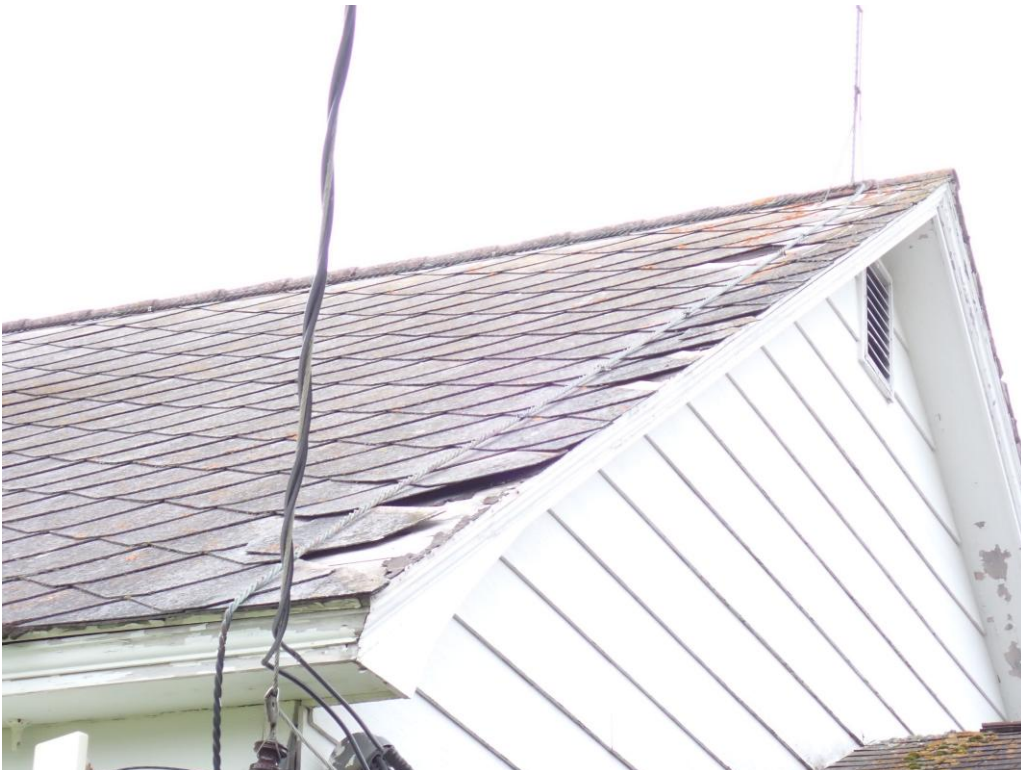
**Photo 46: SW Roof**

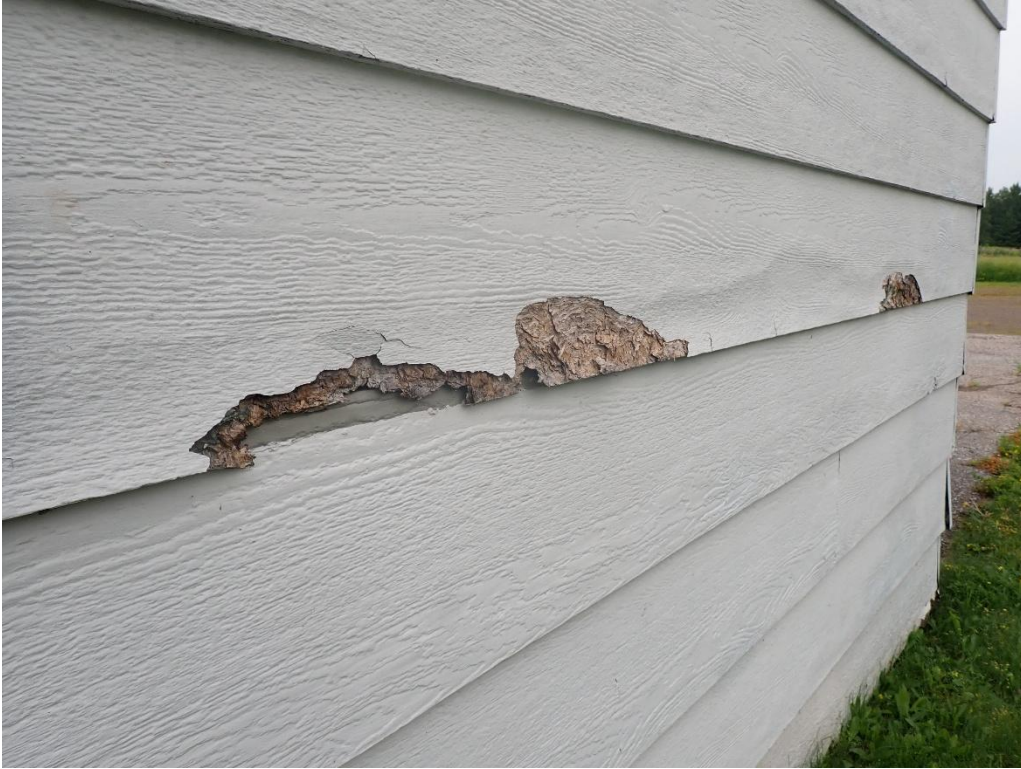
**Photo 47: Example of Deteriorating Siding**
